BUILDING RECORDING

The Griffin Public House

93 Leonard Street
Shoreditch
London

Document Reference Number 2013/1141
Version 2

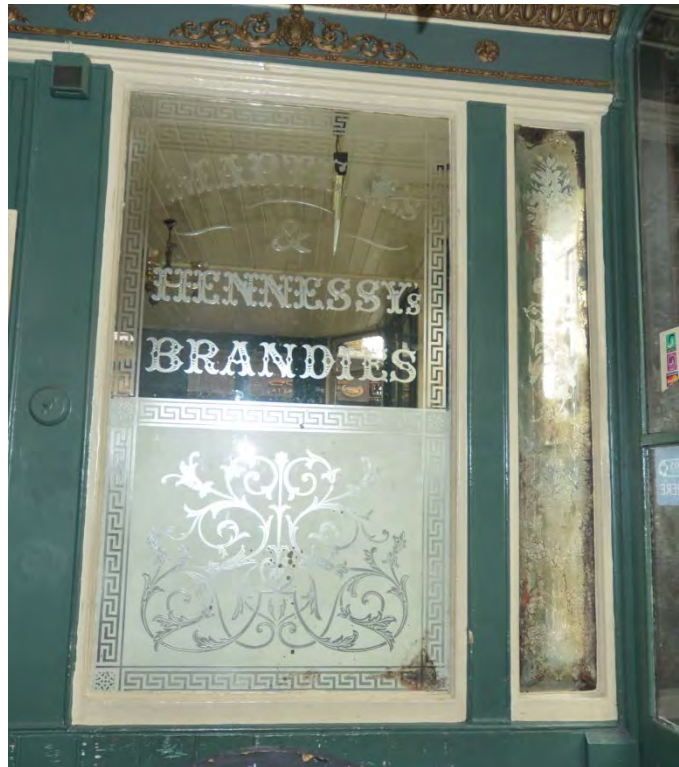
Plate 8: Etched glass mirror, southern end of east wall advertising Martell's & Hennessy's Brandies

Both Martell and Hennessy were established in the 18th century and therefore predate The Griffin. The mirrors are considered to date from a period following the First World War when Hennessy and Martell merged for a brief period.

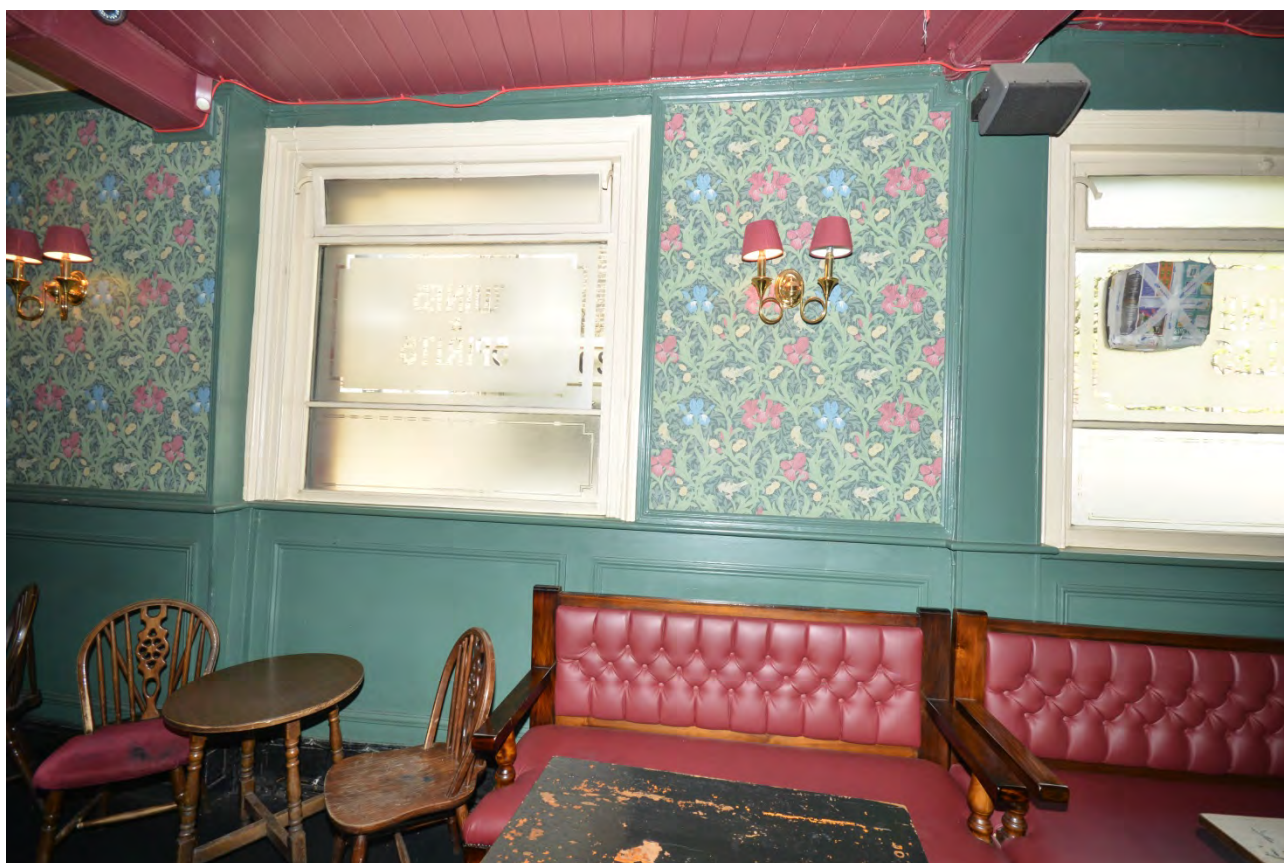
Plate 15: Windows, northern part of western elevation

The windows to the north of the building are clearly different, with square heads and horizontal glazing bars. These are considered to be more recent than those to the south. They may be original to this phase of the building. The etching on the glass gives no indication as to date.

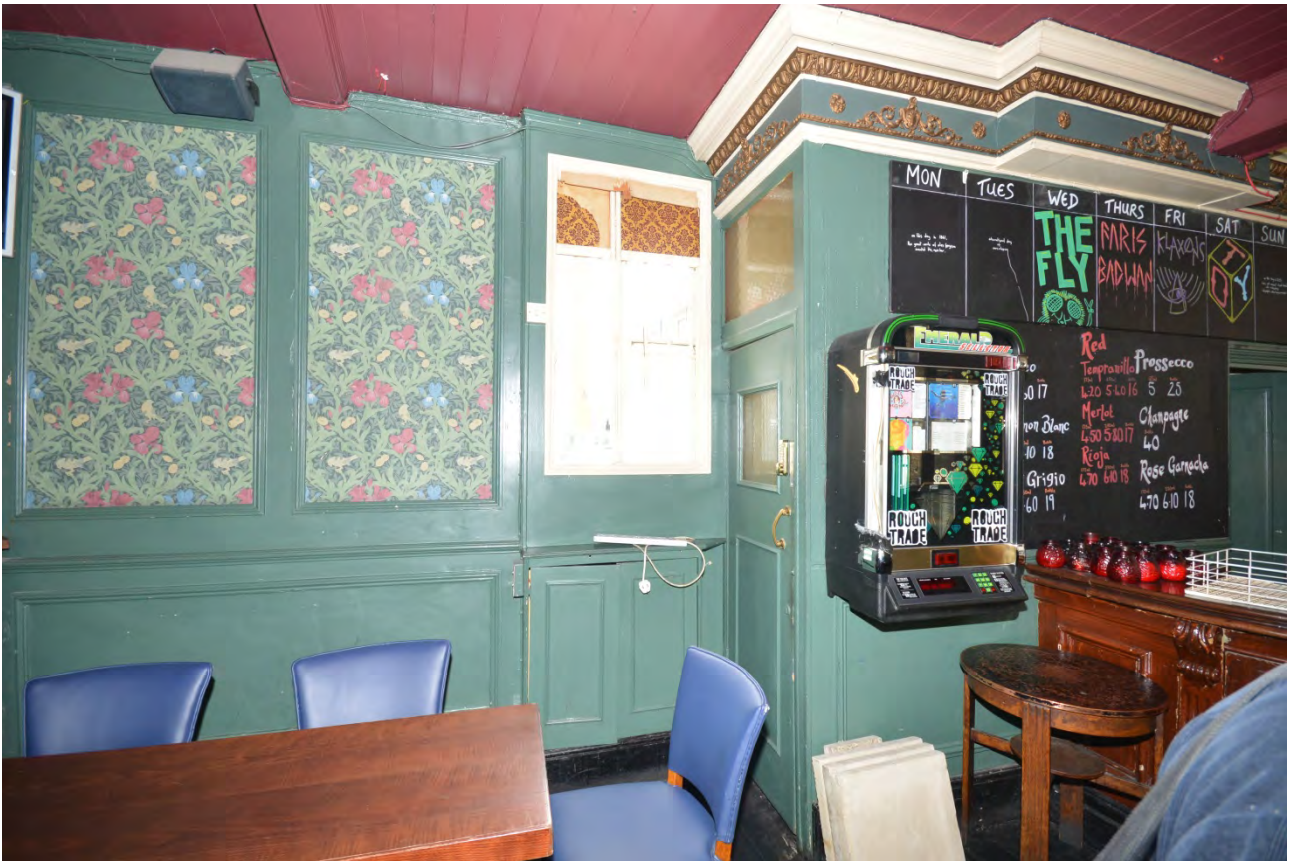
Plate 16: Panelling on east wall, towards northern end of bar

Panelling found beneath the cornice and frieze is considered to be contemporary with or earlier than the mouldings as these are affixed to the panelling. As the mouldings span parts of the building constructed in phases 1 and 2, they, and consequently the panelling, must date to phase 2 or later, therefore must postdate 1872.

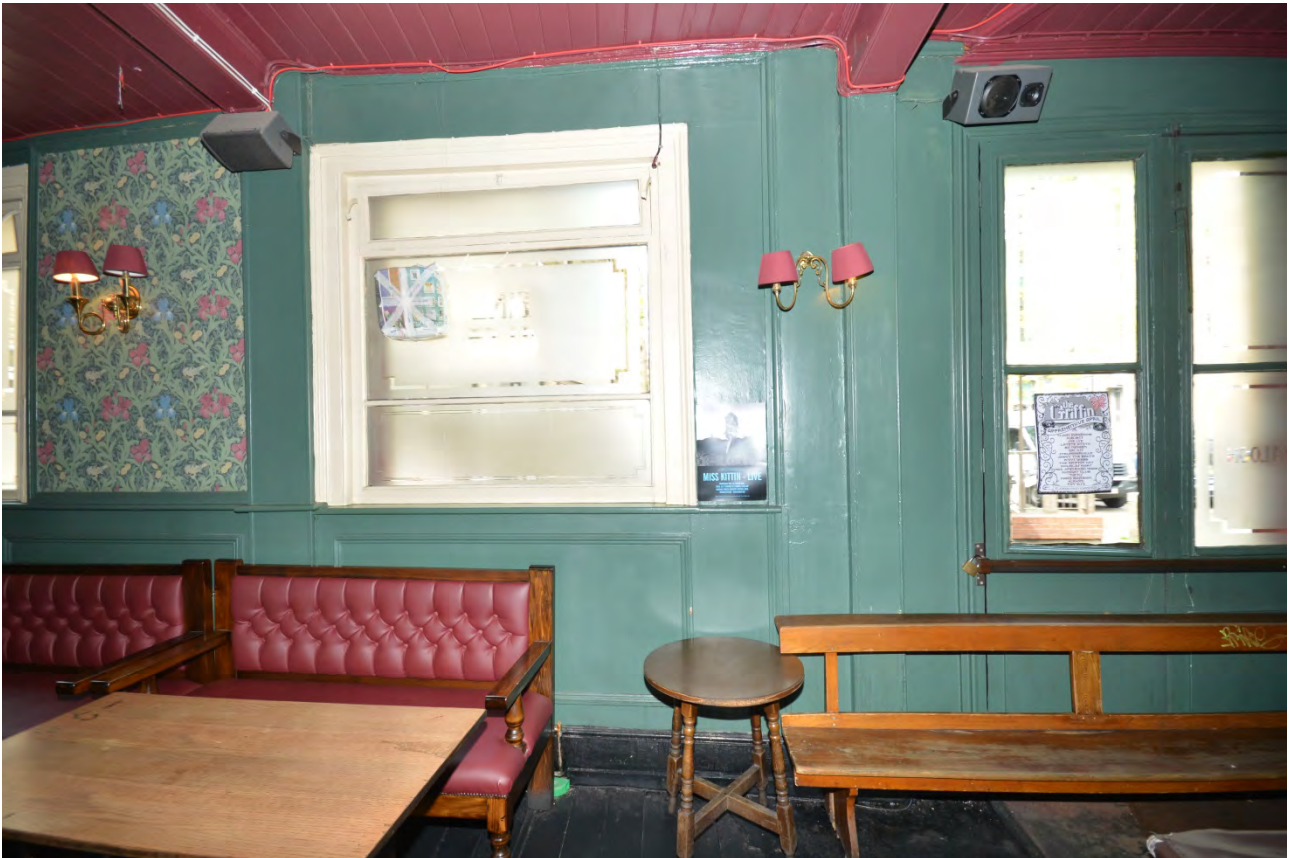
Plate 17: Panelling of questionable date, west wall

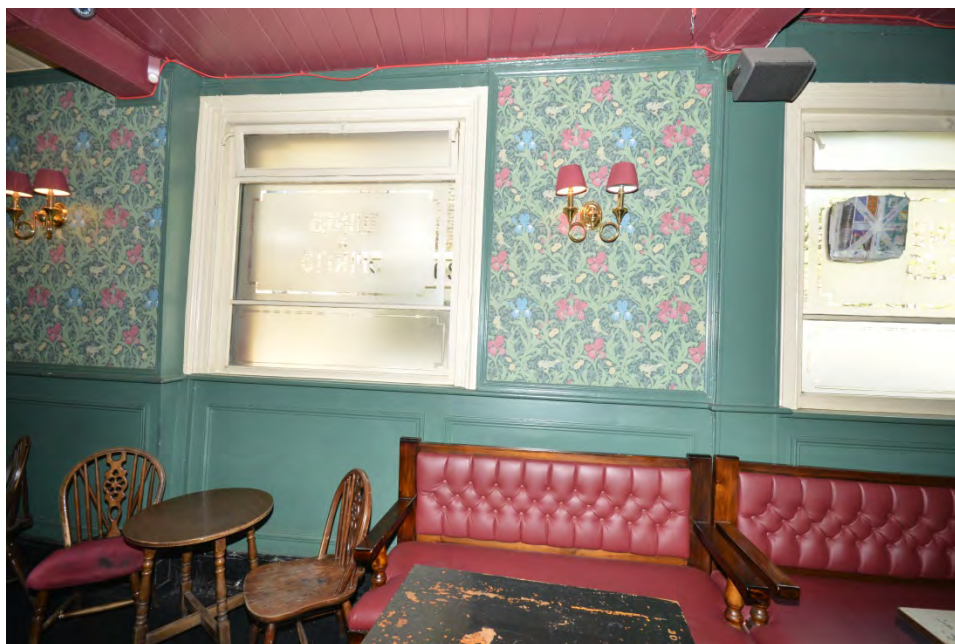
Plate 18: Panelling of possible recent date, east wall

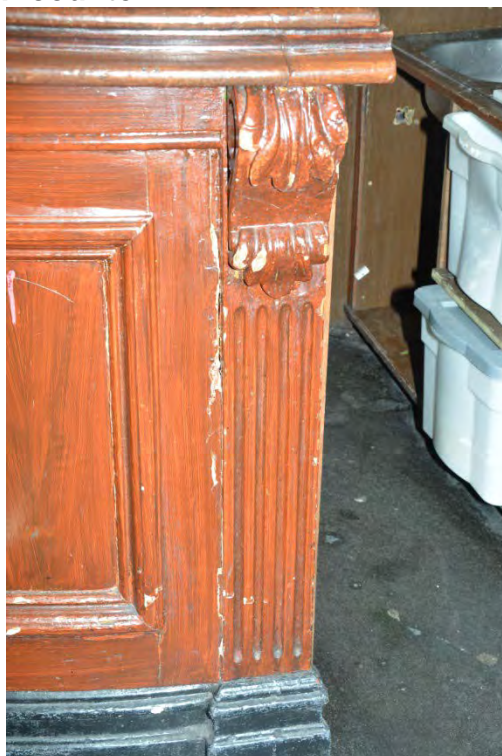
Plate 26: Detail of moulding, bar counter

The majority, if not all, of the bar was replaced following a 2003 planning application. It is therefore not a historic feature.

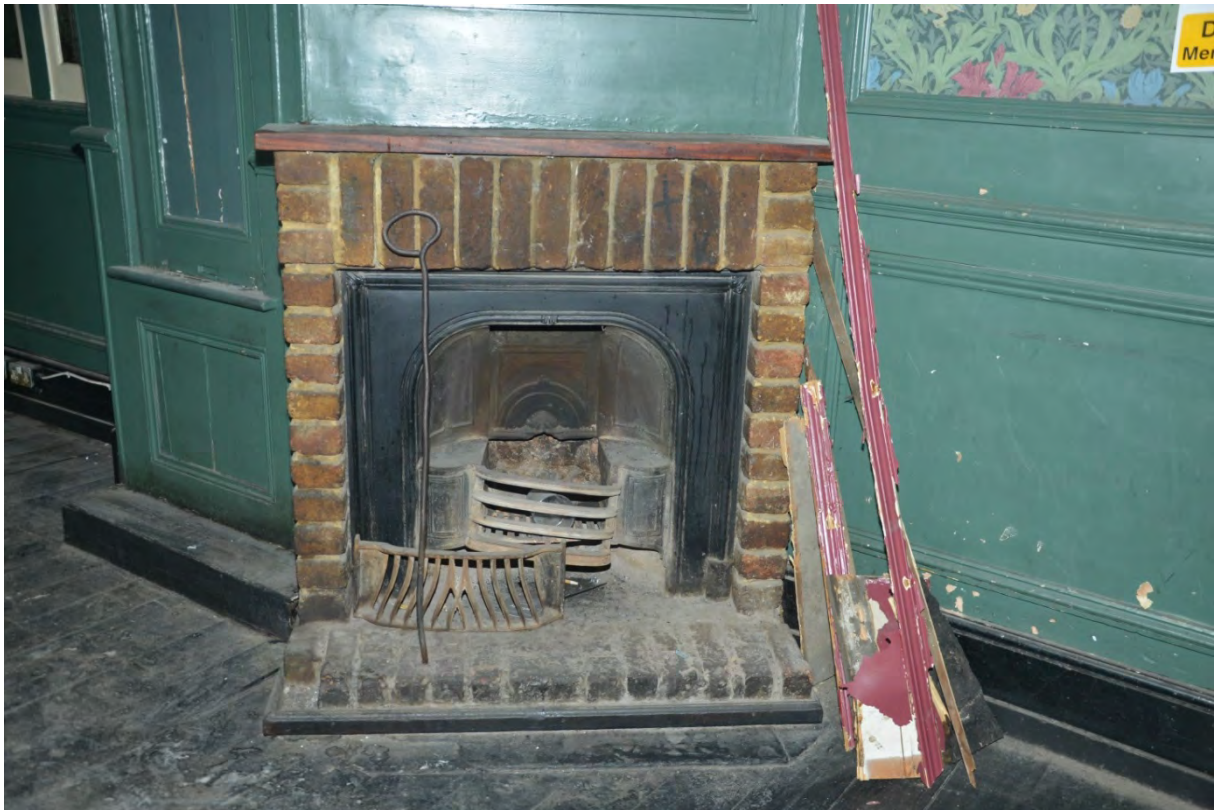
Plate 27: Fireplace, eastern wall

The fireplace to the north of the bar counter, against the eastern wall, comprises a mid-late 19th century cast iron insert with early-mid 20th century brick surround.

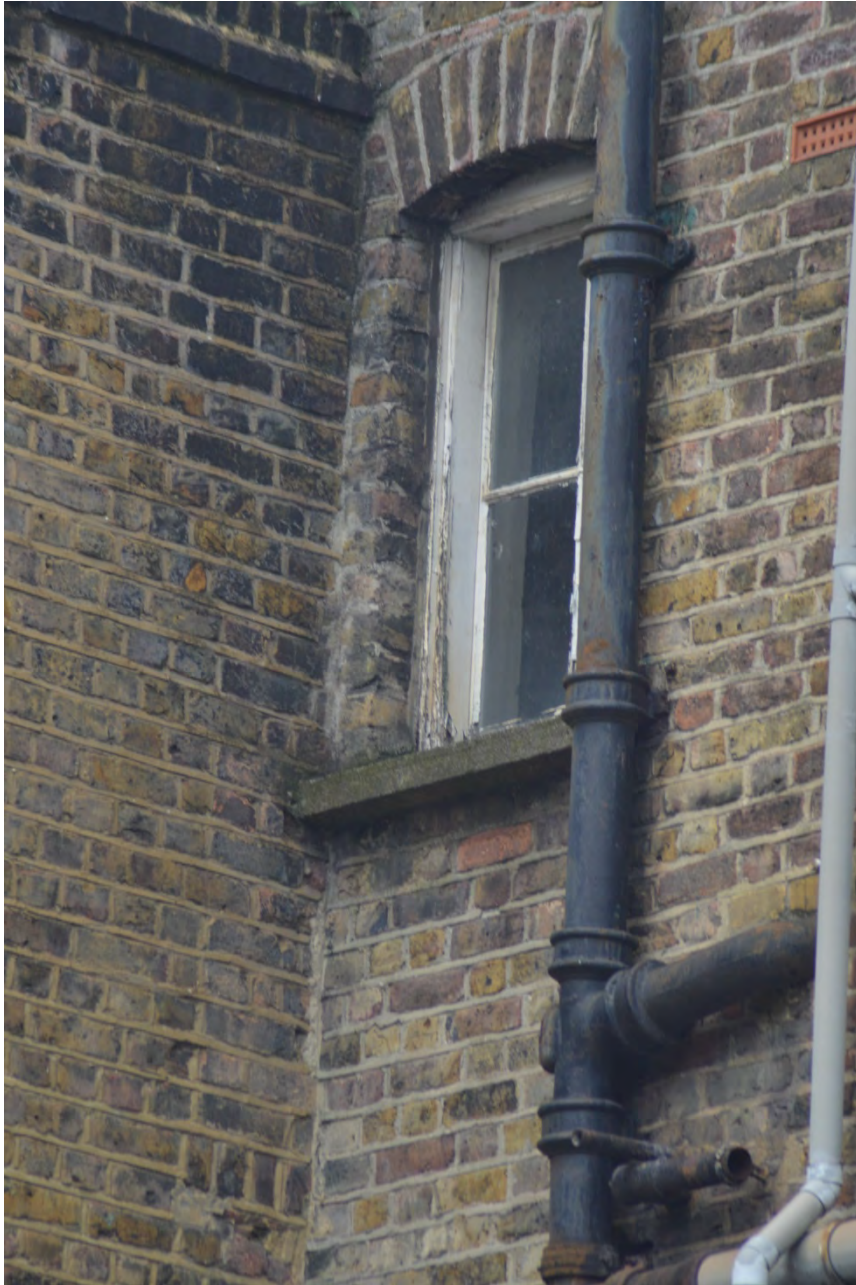
Plate 48: Detail of join between The Griffin and No 5 Ravey Street, west elevation

At its northern end, The Griffin joins to the neighbouring property. It is clear from the above image that the walls are not tied in to each other. Black staining to the east wall of the Griffin (left of Plate 48) is not continued on the wall of No 5 Ravey Street, suggesting this building is a later addition to the rear of The Griffin.

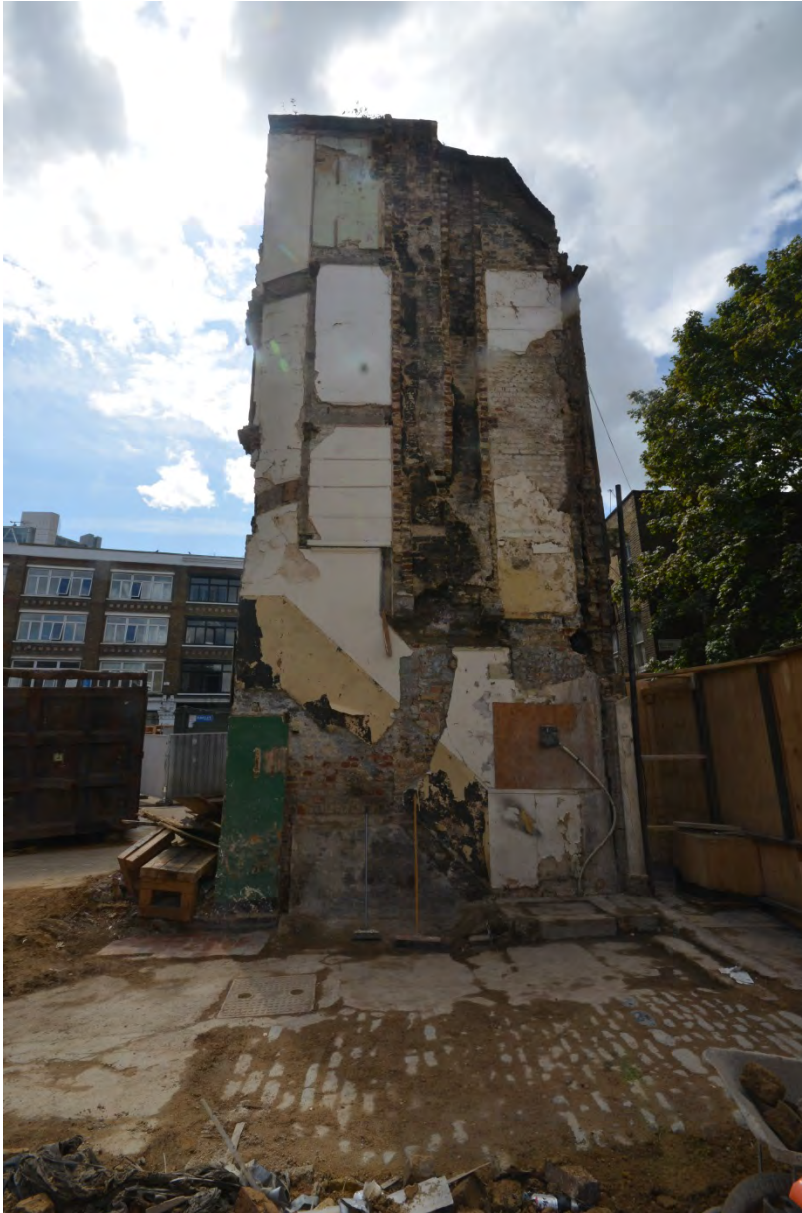
Plate 49: The northern wall of The Griffin

Following the demolition of 5 Ravey Street in 2014, the northern wall of The Griffin was exposed. Photographs of the wall, which was also the internal wall of 5 Ravey Street, follow, taken prior to the failure of the structural stability of the wall, resulting in its demolition and subsequent replacement.

The exposed northern wall included a chimneybreast running from the first floor up. It is thought likely the chimneys served The Griffin as a staircase was present in this location in 5 Ravey St.

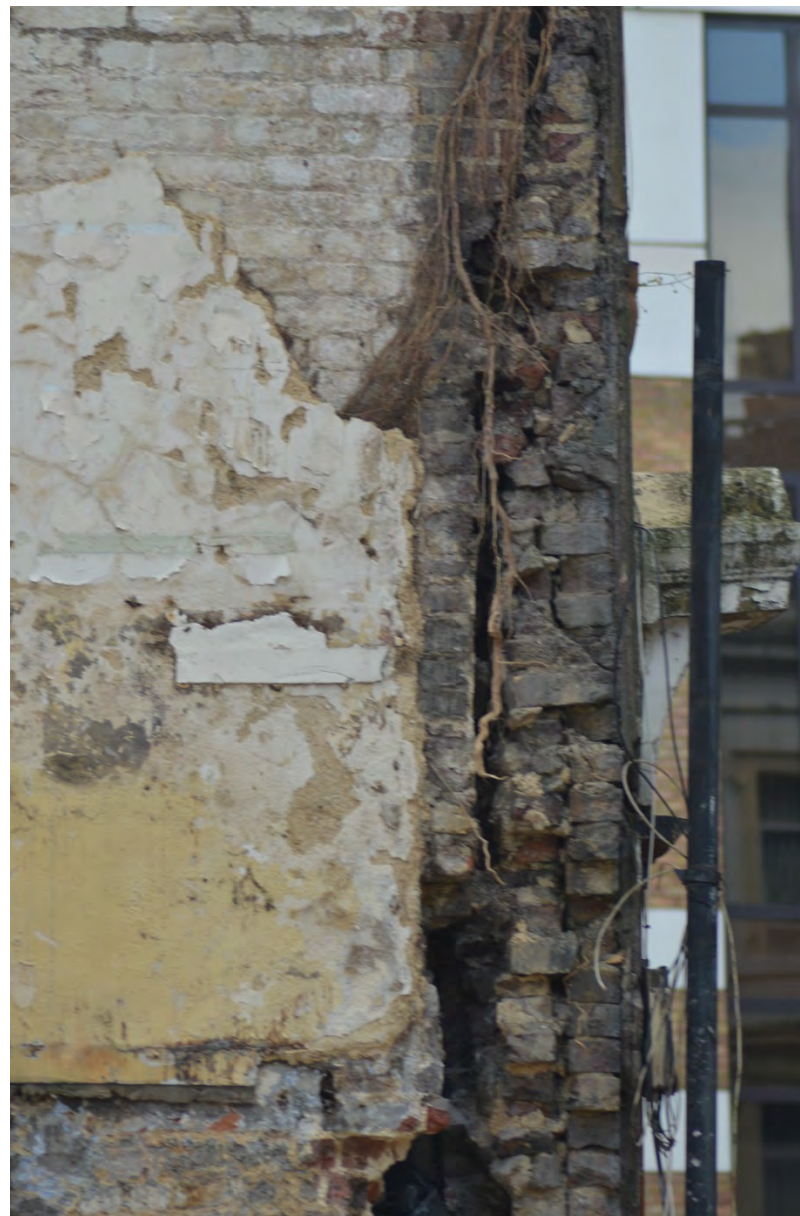
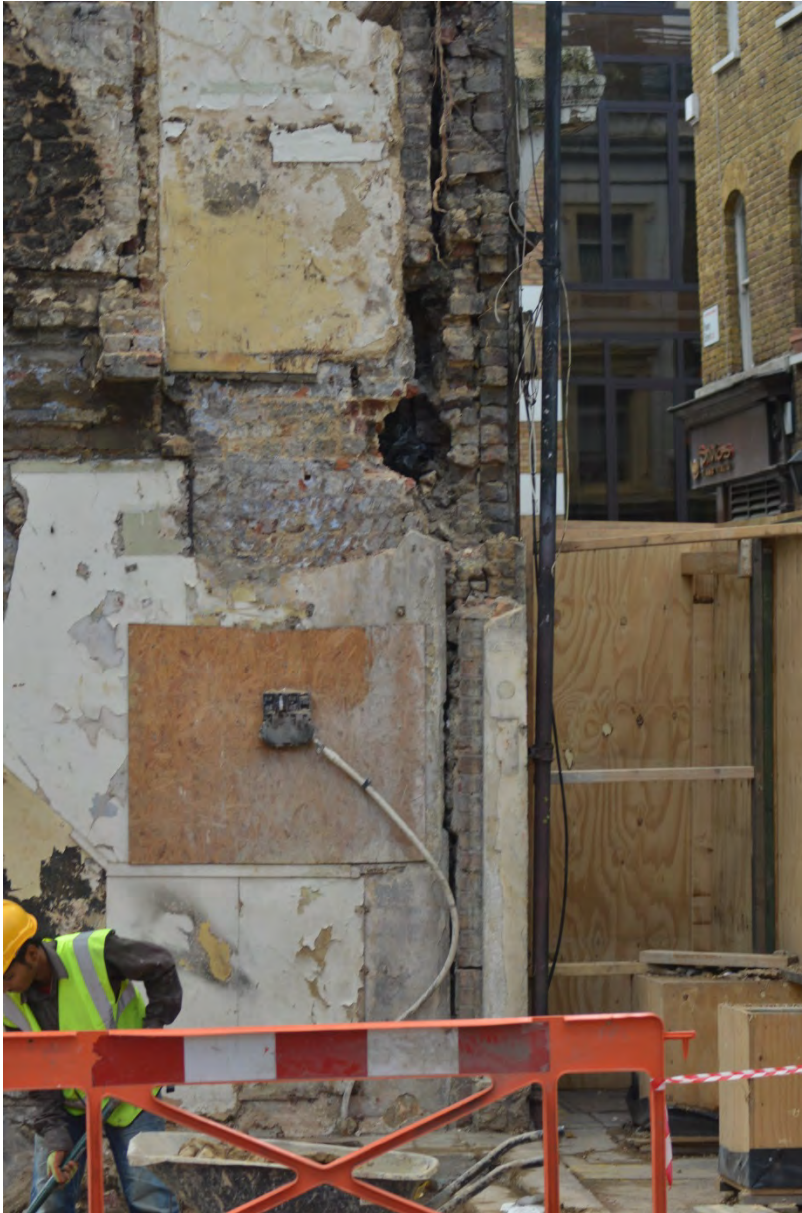
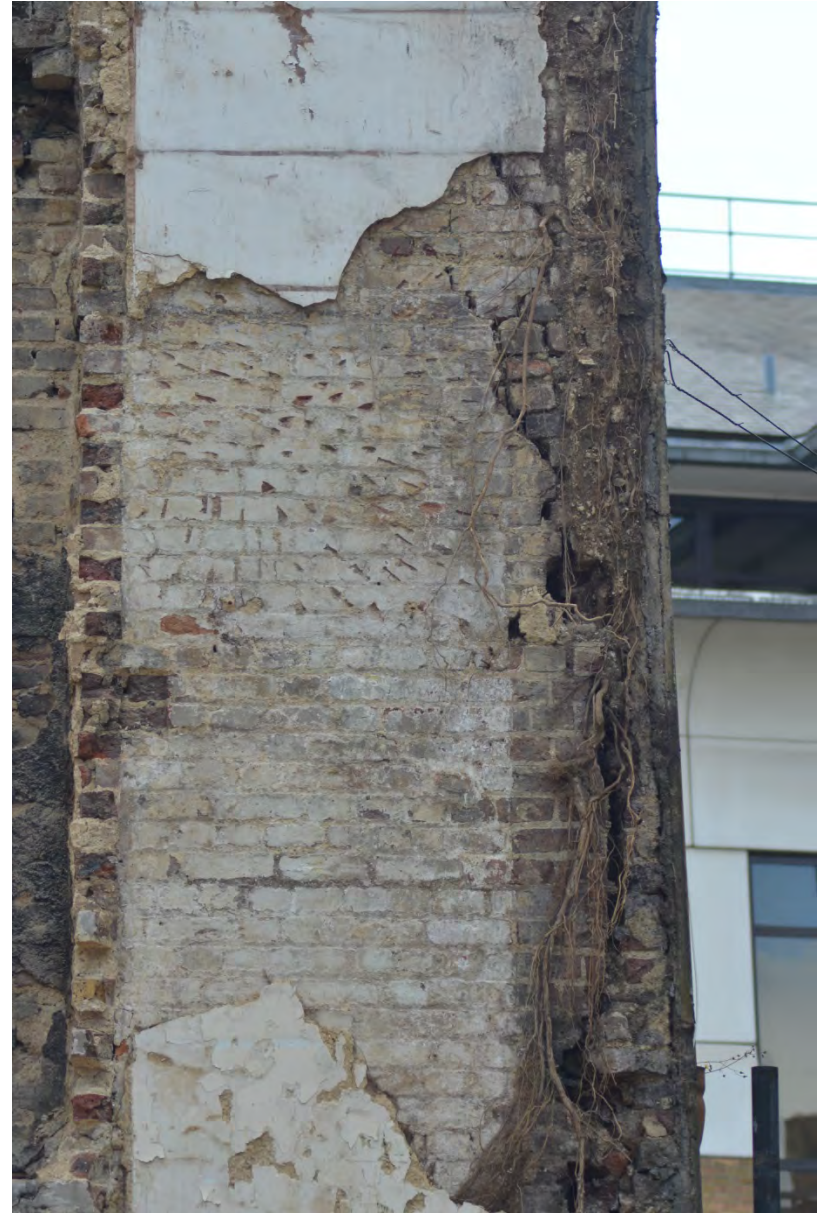
Plate 52: Detail of structural crack, west end of north elevation

Plate 53: Detail of structural crack, west end of north elevation

Plate 54: Detail of structural crack, west end of north elevation

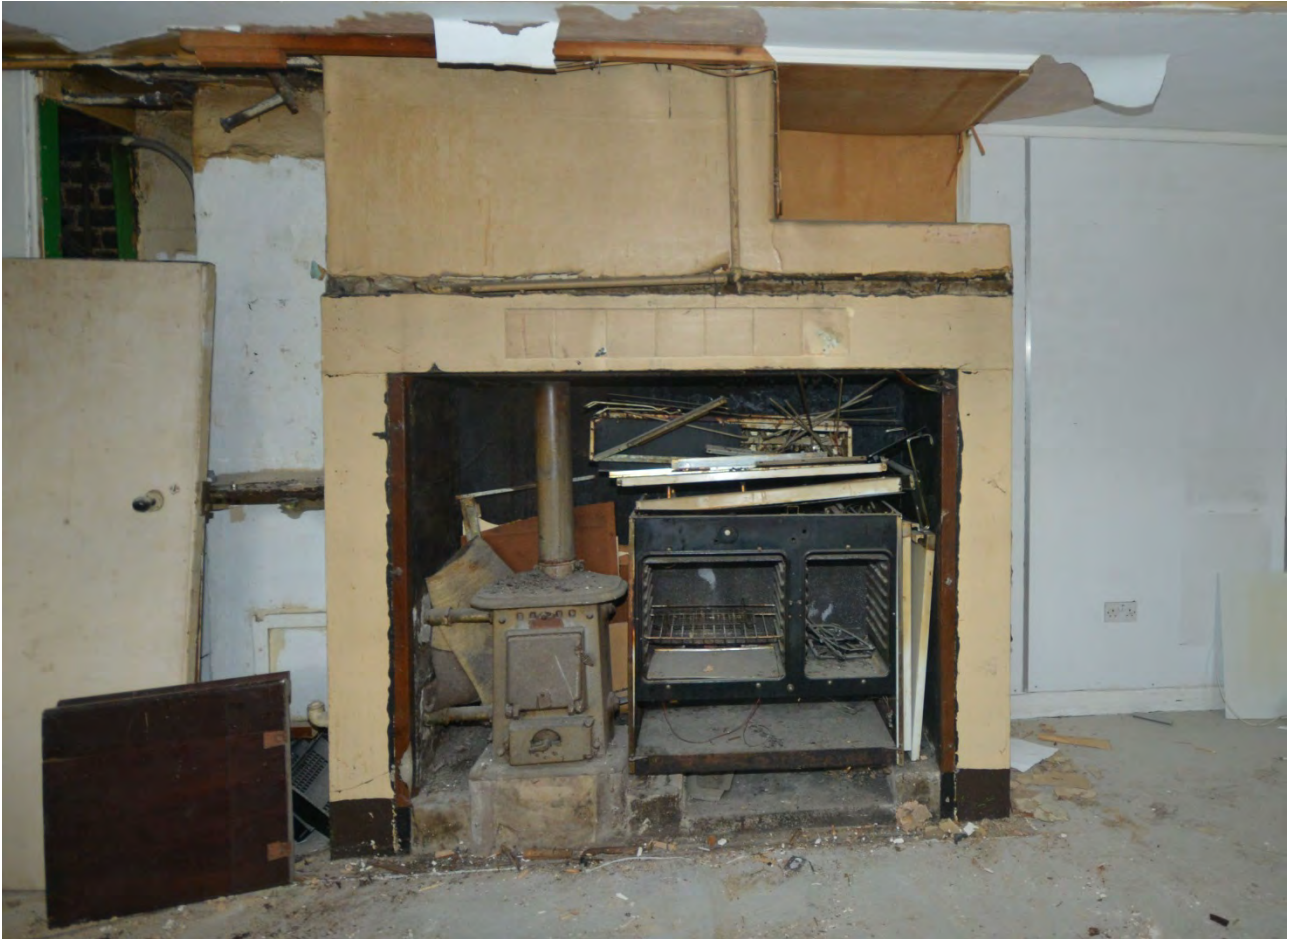
Plate 123: Fireplace exposed as part of alteration works

The cladding over the fireplace was removed as part of the consented alteration works, revealing a kitchen fireplace with gas cooker and solid fuel boiler, both considered to date from the early to mid 20th century.

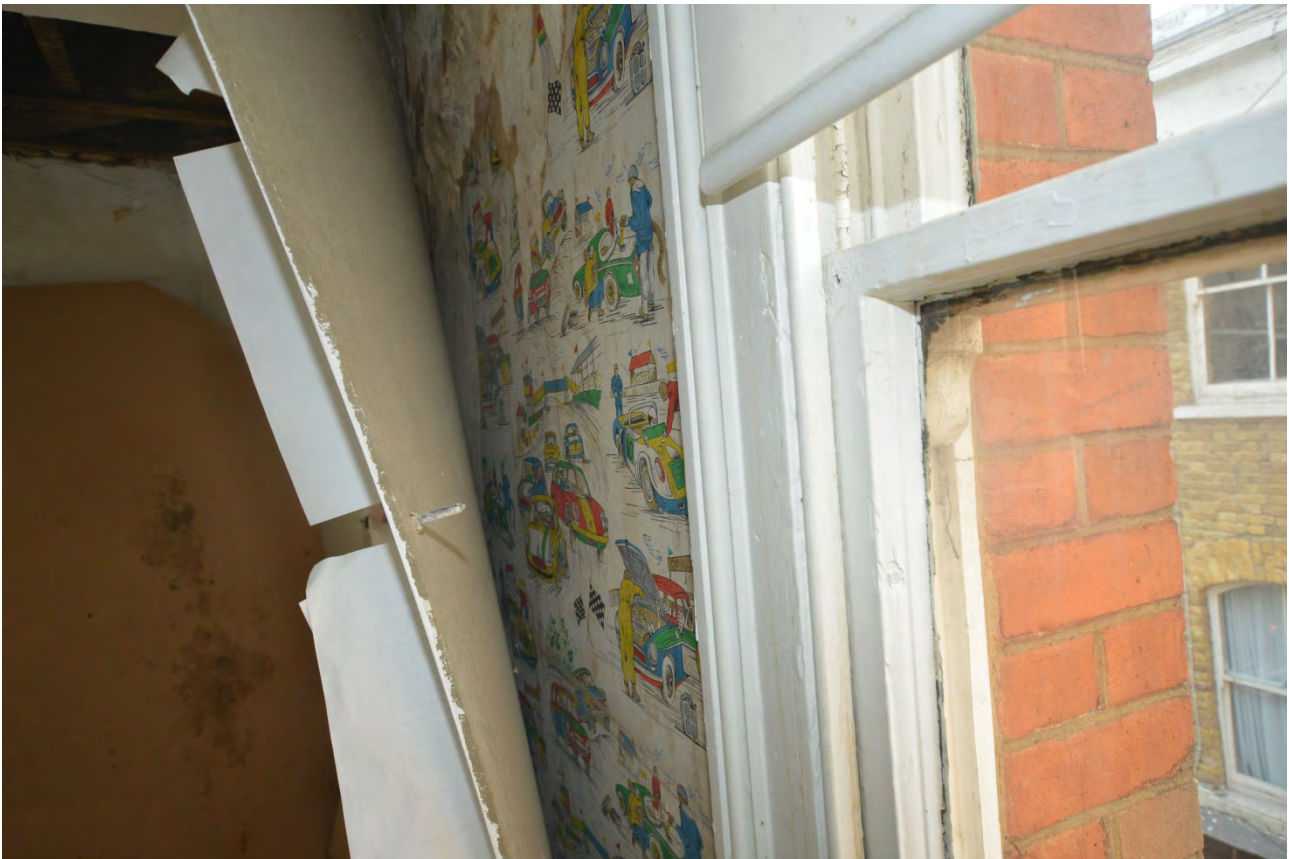
Plate 148: View behind lining, west wall, showing c. 1960s wallpaper

The wallpaper, depicting motor racing, suggests that during the 1960-70s, this room was once a children's bedroom.

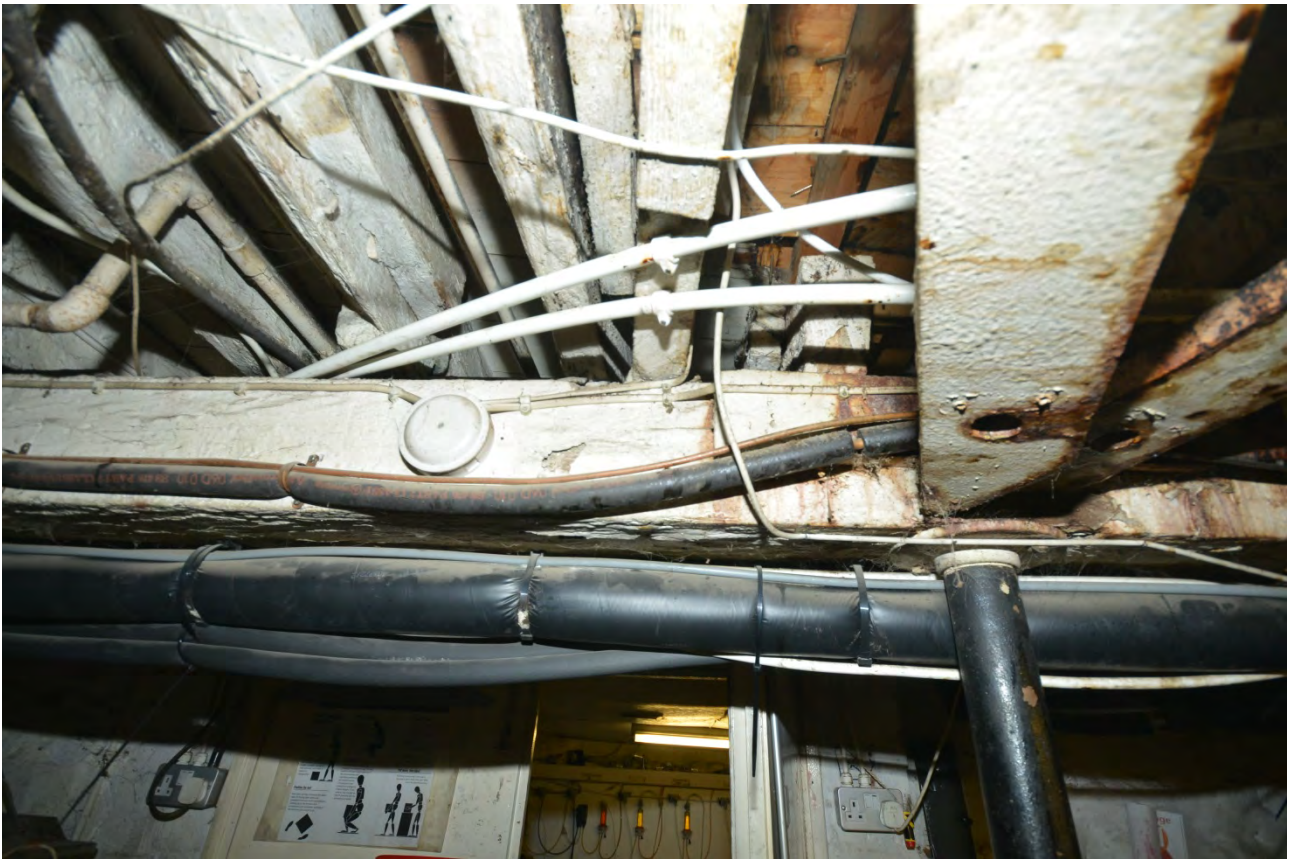
Plate 164: Detail of cellar ceiling joists

The joists depicted are machine-sawn timber and steel. A steel supporting post is noted to the right of the image.

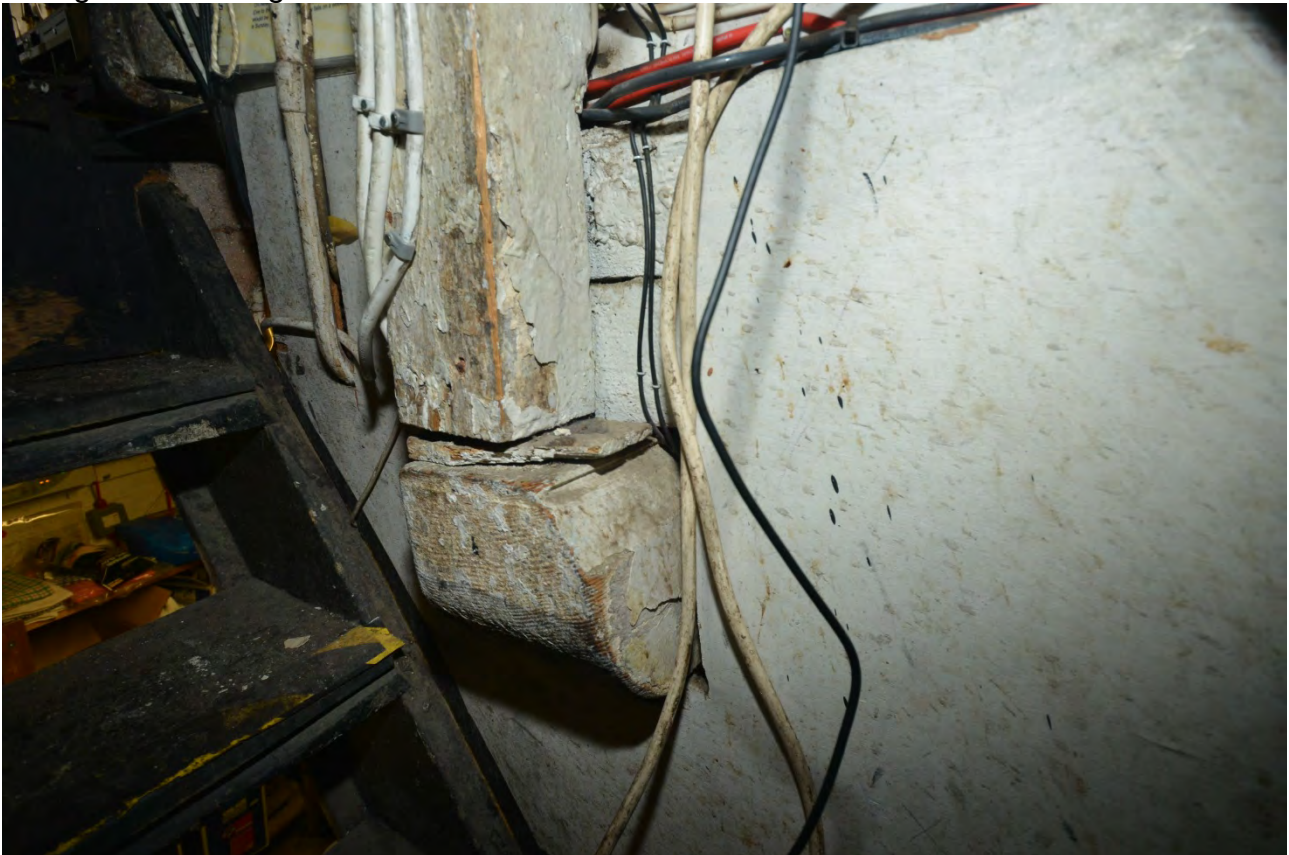
Plate 165: Detail of corbel, cellar

Above the staircase, a timber post supporting the ground floor is in turn supported on a corbel, projecting from the wall.

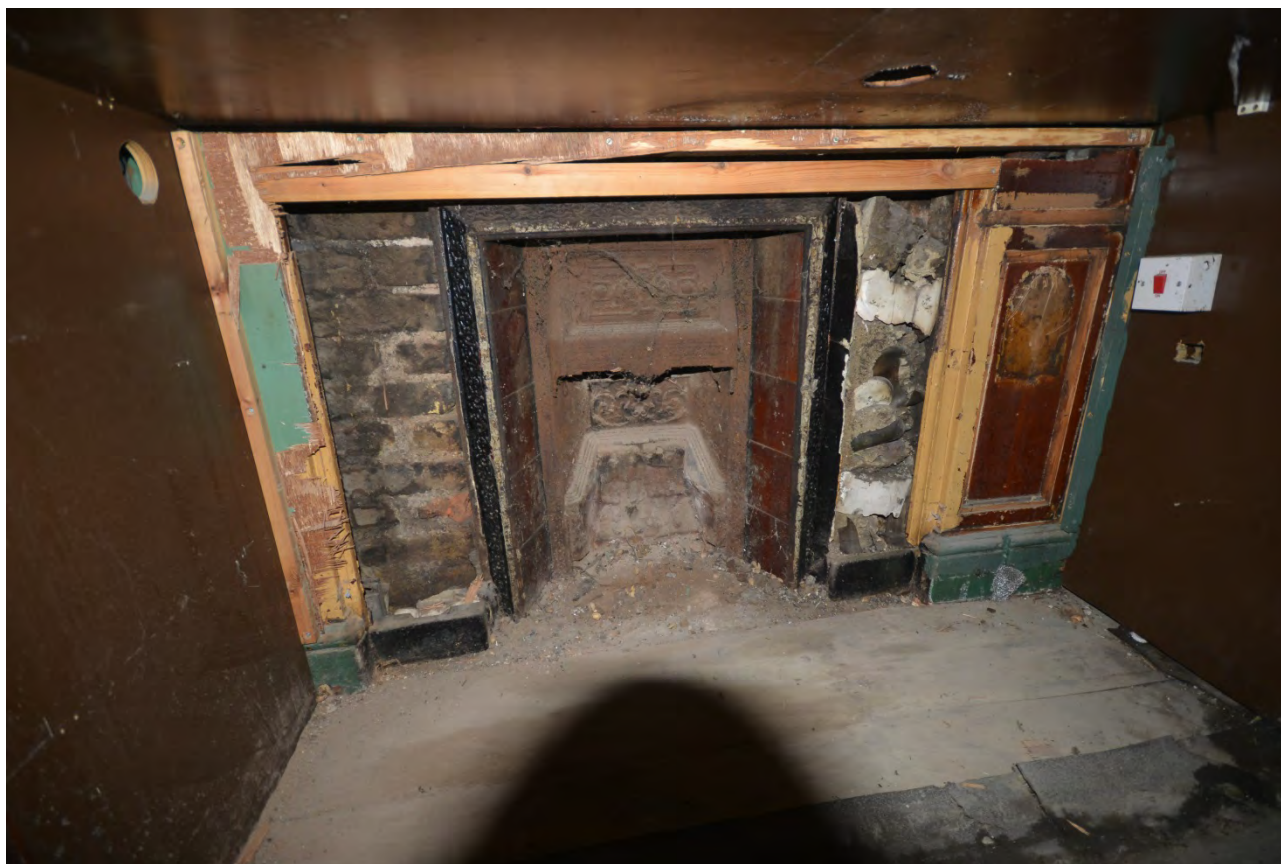
Plate 166: Fireplace revealed during strip of back bar area

The fireplace depicted above was revealed during stripping of the back bar area towards the southern end of the servery. It was covered by a sheet of timber at the rear of a recess in which refrigerators were fitted when the public house was operational.

A section of original panelling and skirting is visible to the right of the fireplace, which itself features a cast iron tiled insert with plain tiles. The fire basket is missing. This form of fireplace is common to the late 19th – early 20th centuries.

Bare brick to the left and bottles and general refuse bonded in mortar to the right indicates the location of a former fire surround and mantle shelf, considered to have been removed when the fireplace was boarded over. The presence of general refuse forming the wall to the right may indicate the opening was once larger and has been reduced in size using whatever materials were to hand in order to accommodate the insert now present.

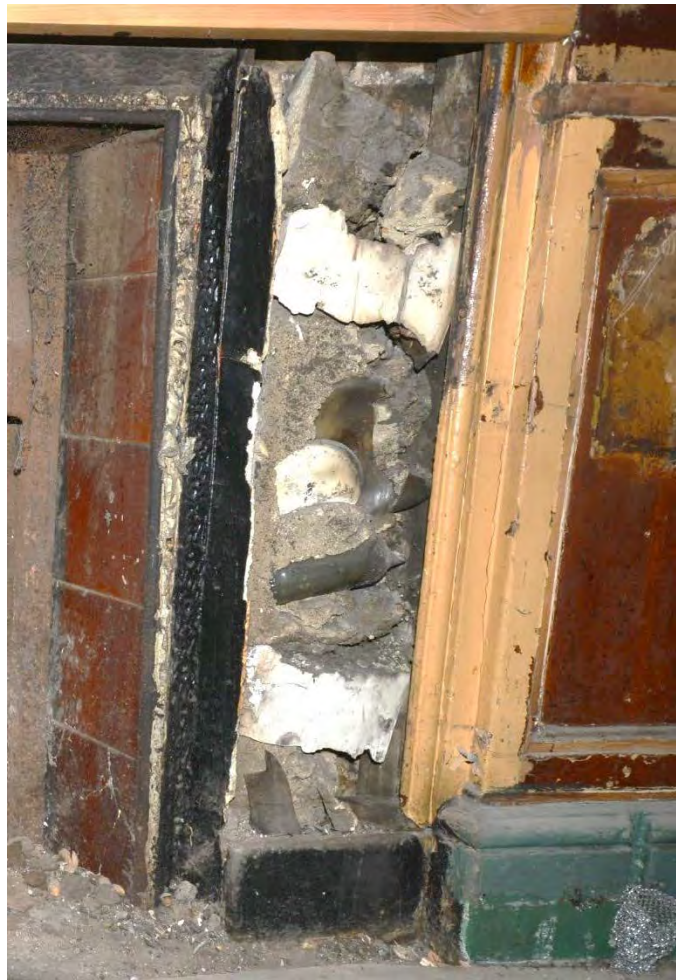
Plate 167: Detail of bottles and refuse forming right hand wall of fireplace

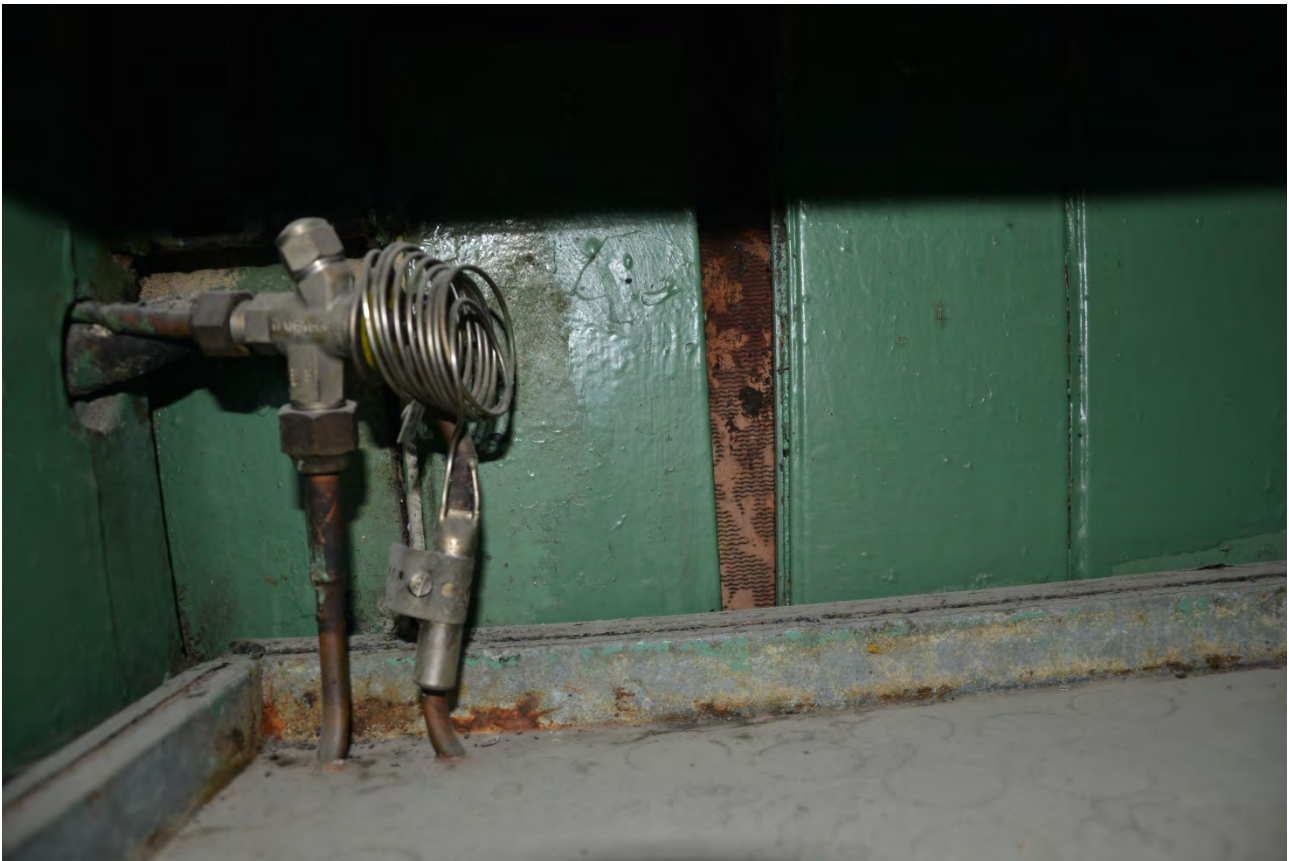
Plate 169: Early wallpaper revealed on eastern wall

To the north of the fireplace, a gap in tongue and groove panelling at the rear of the under-counter shelving has revealed historic wallpaper with a floral motif of an uncertain date. It is clear, in this area at least, the tongue and groove panelling cannot be original.
