BLOCK 9 EXTENSION, ST. THOMAS' HOSPITAL, LAMBETH PALACE ROAD, LONDON, SE1 7EH
For
KINGS COLLEGE LONDON

FINAL REPORT
PHASE 1 PRELIMINARY CONTAMINATION RISK ASSESSMENT REPORT

Project Name: Block 9 Extension, St. Thomas' Hospital, Lambeth Palace Road, London

Document No: EWGCE-15640-XX-R-BDA-001

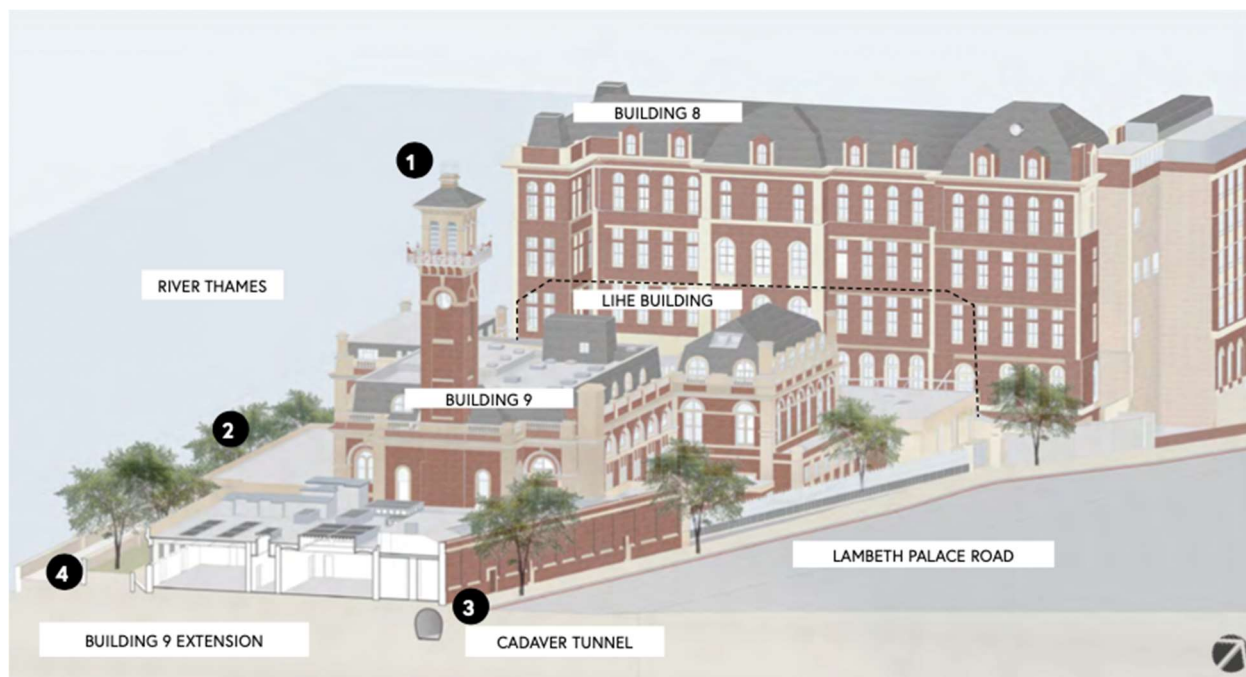
Figure 3: Existing Site Layout

Taken from Building 9 Extension Design Statement (23567-8003-00, dated October 2023)

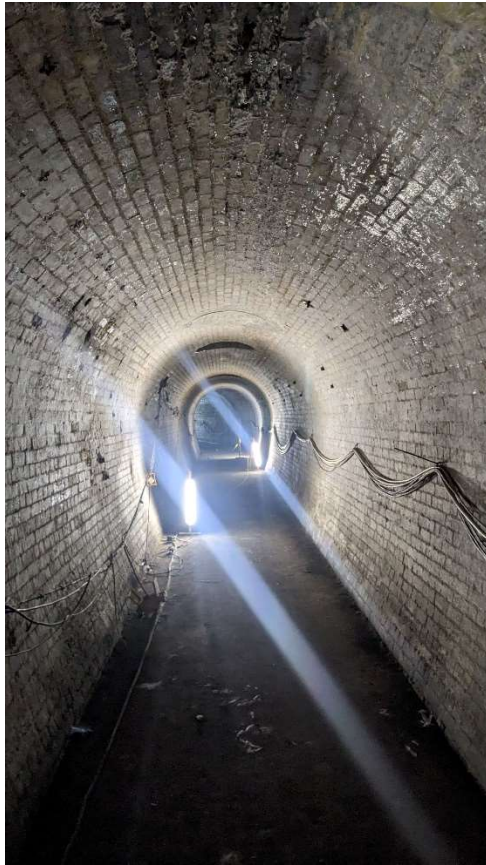
Photo 1: View of the tunnel

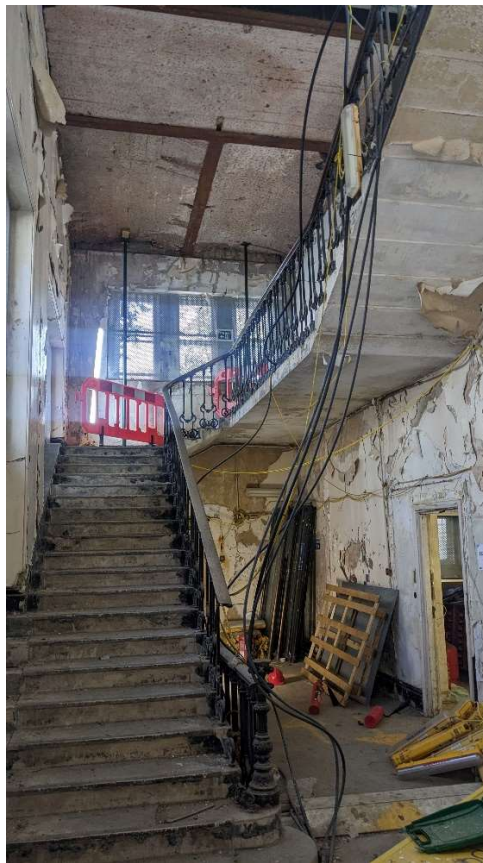
Photo 2: View of the existing staircase

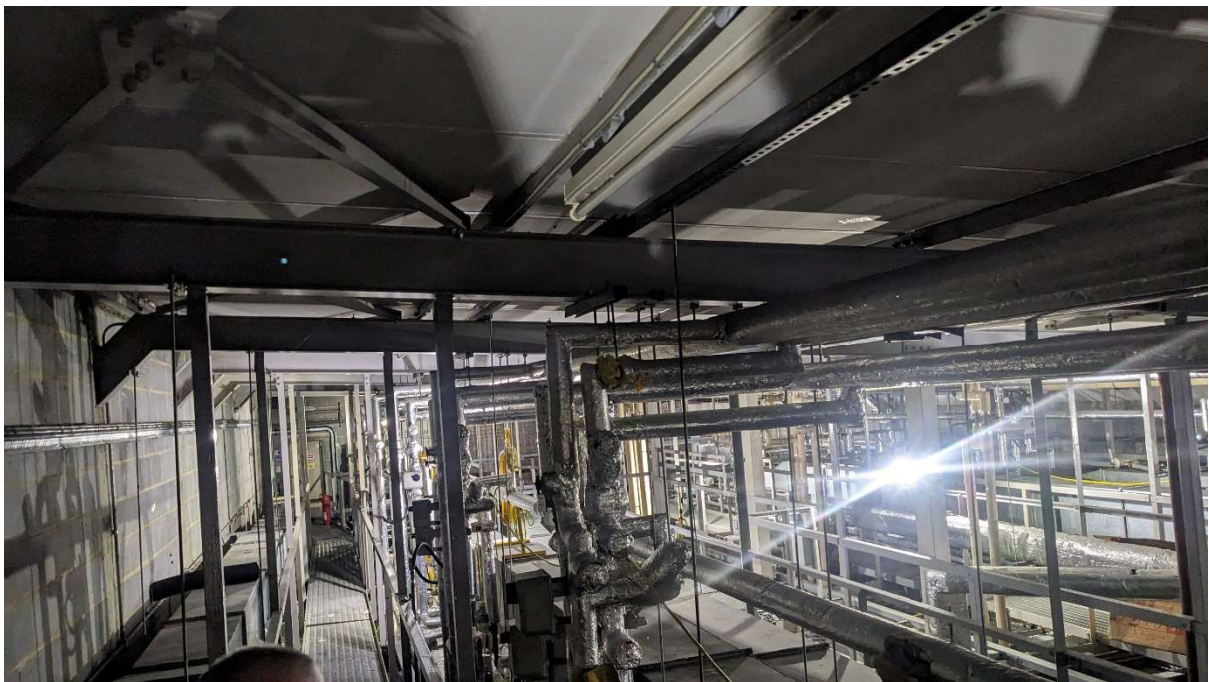
Photo 4: View of the plant room

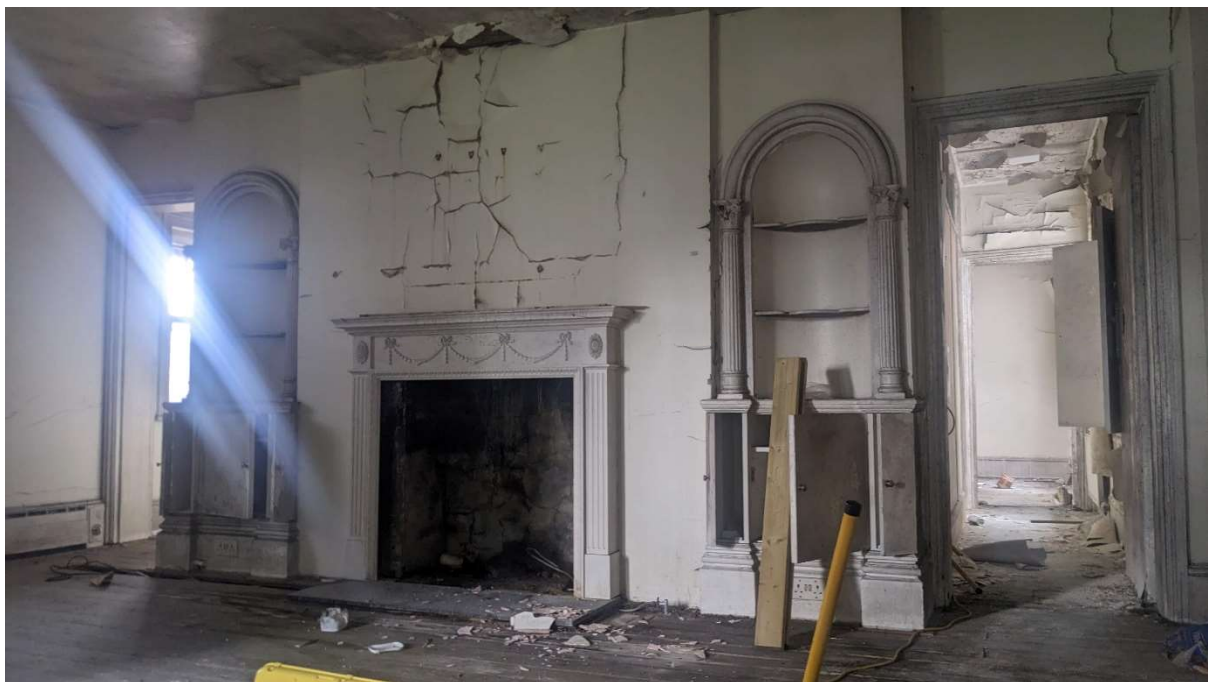
Photo 6: View of the Chimney

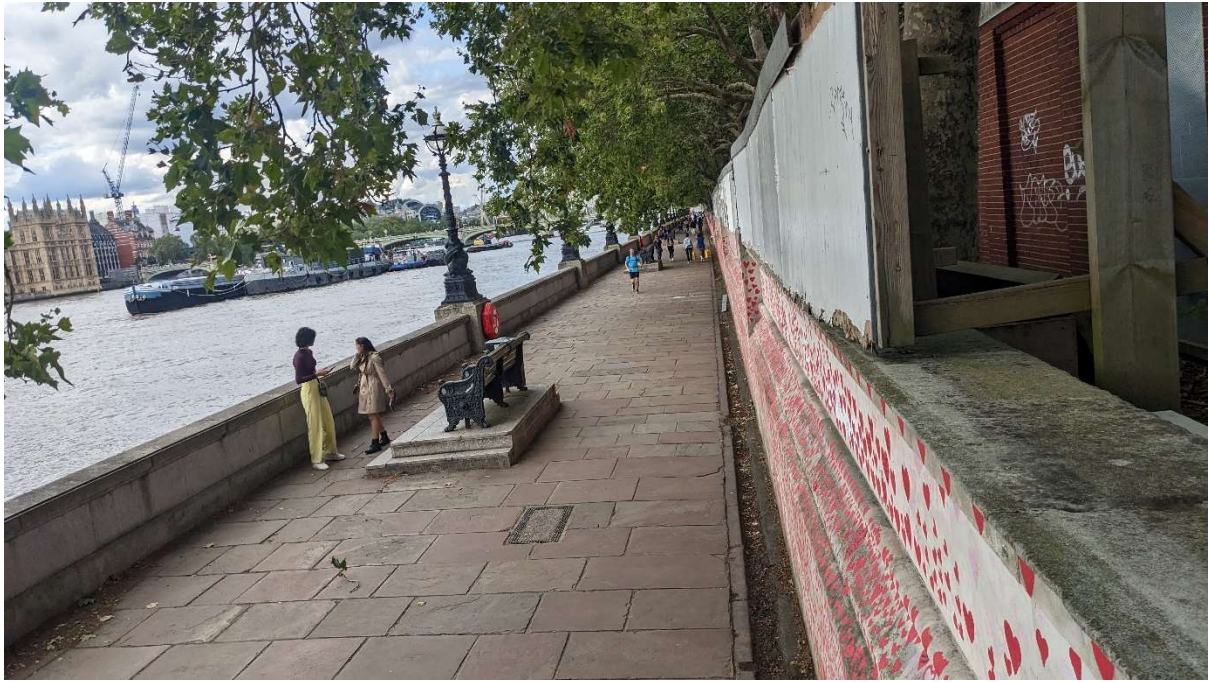
Photo 7: View of the wall along the river way

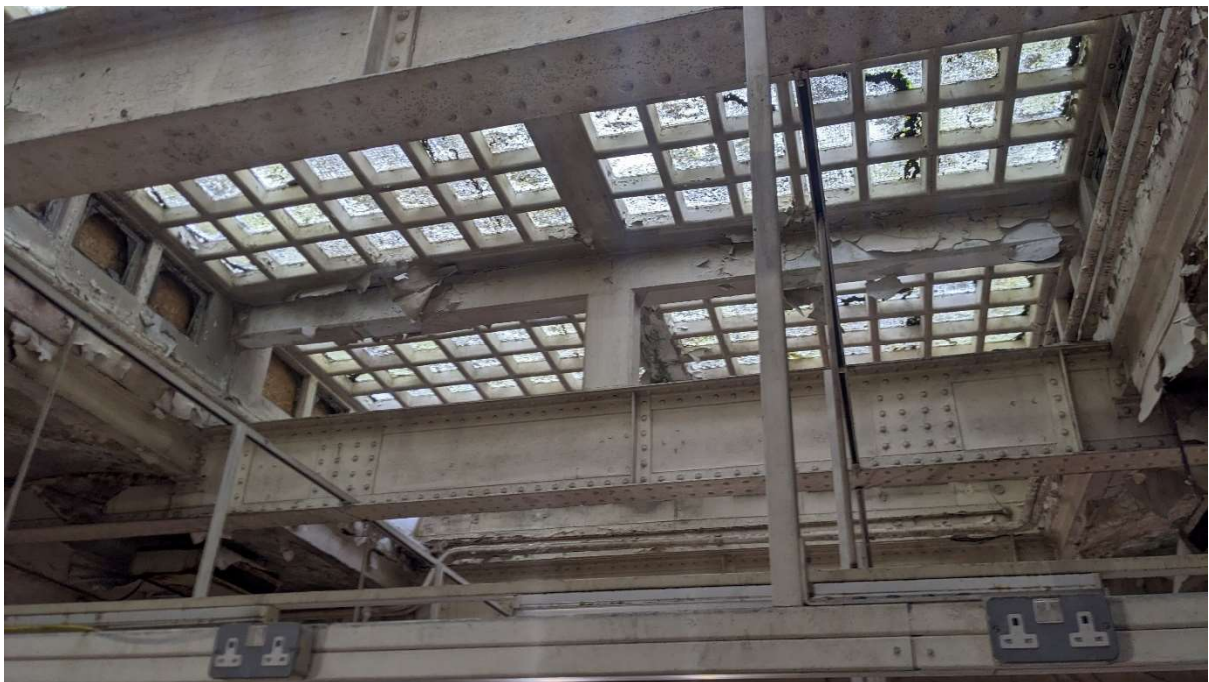
Photo 10: Internal views of the existing roof
