BUILDING RECORDING

The Griffin Public House

93 Leonard Street
Shoreditch
London

Document Reference Number 2013/1141
Version 2

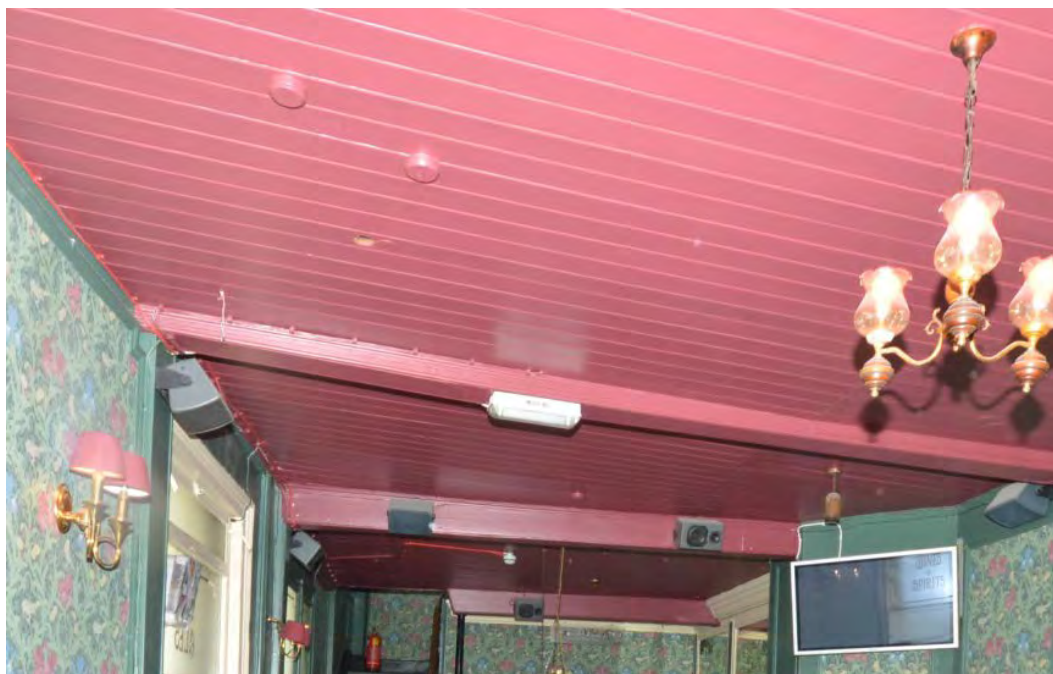
Plate 1: Ceiling, north end

The ceiling is panelled with tongue and groove planks. This is not a historic ceiling form.

There is no plaster ceiling beneath this, and there is evidence that the tongue and groove planks abut the cornice rather than run beneath it and therefore postdate the installation of the cornice.

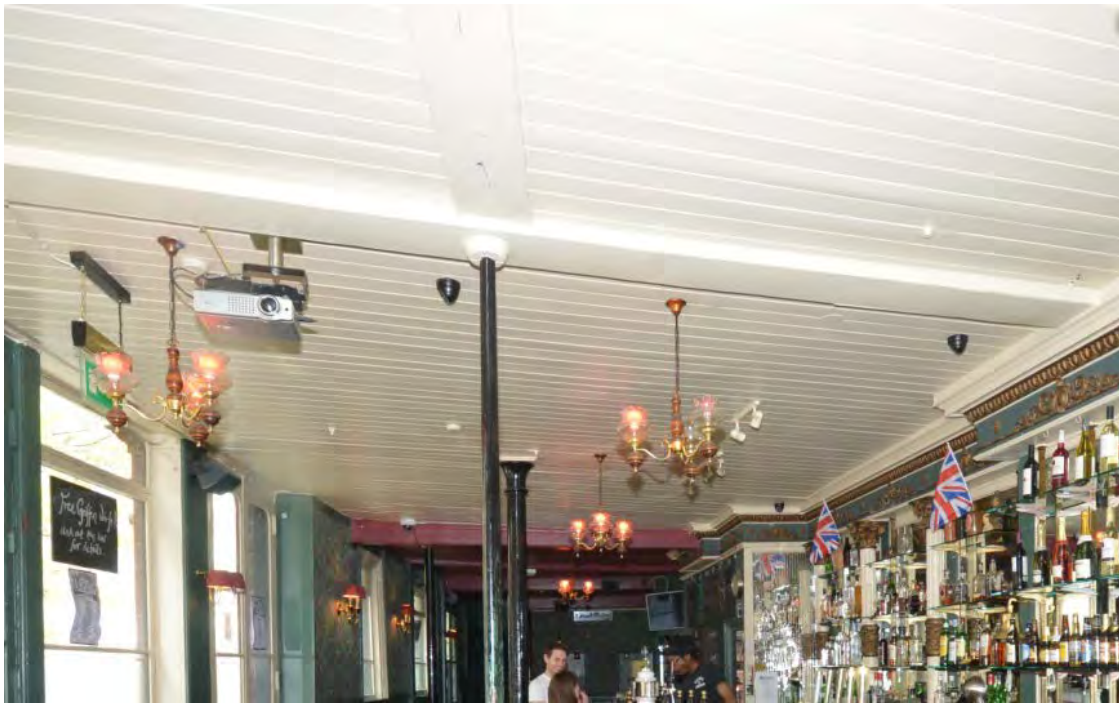
Plate 2: Ceiling, south end

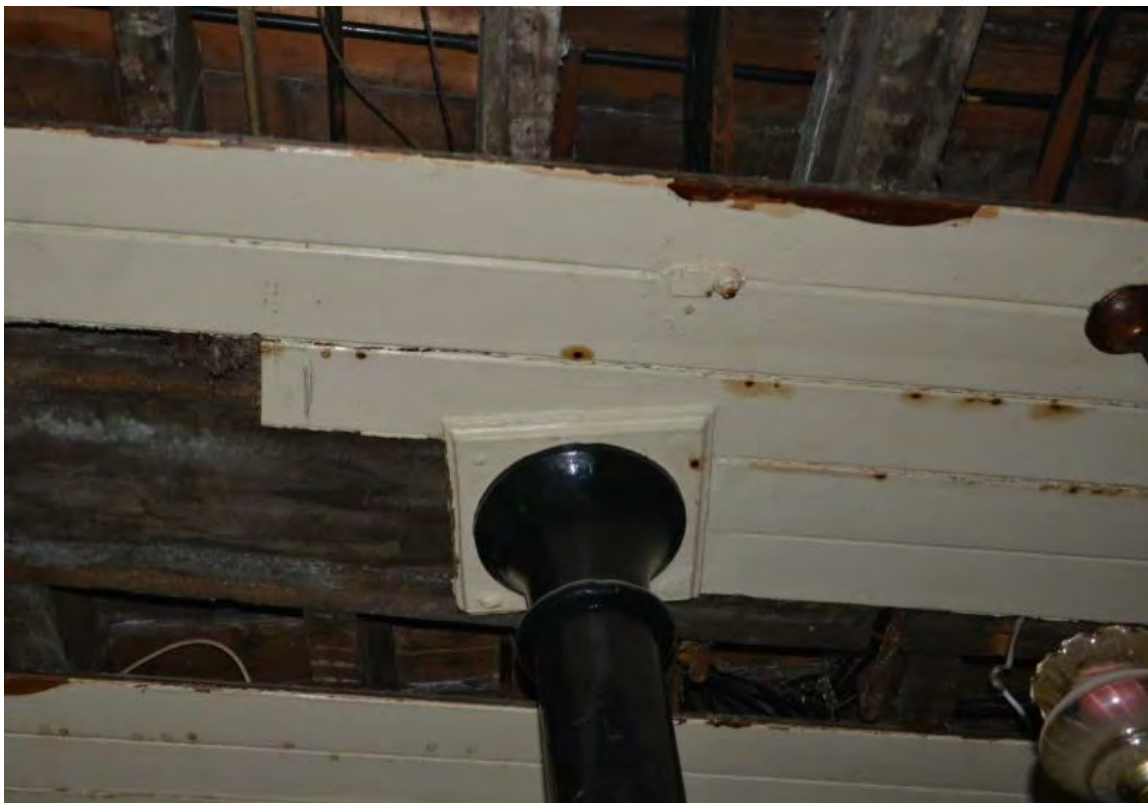
Investigative works have revealed scars from a former lath and plaster ceiling.

Plate 3: Lath & plaster marks revealed beneath tongue and groove

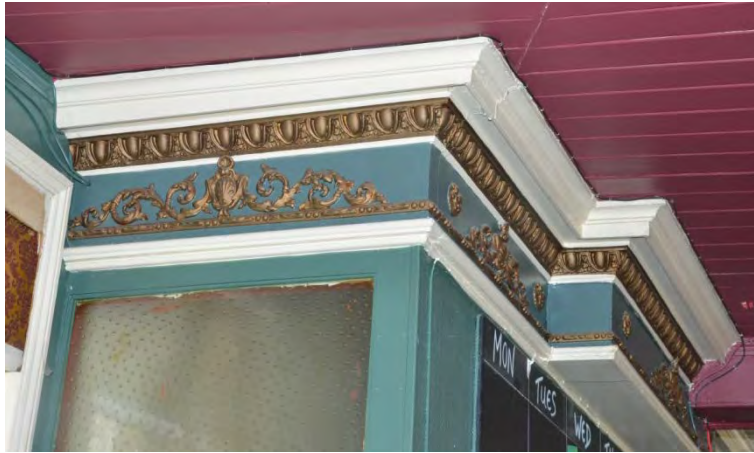
Plate 4: Cornice and moulding, east wall

The eastern wall features a moulded cornice and frieze with further decorative mouldings and columns. These run from the enclosure of the cellar staircase south to the southern wall of the building.

The cornice spans both phases 1 and 2 of the building and must therefore date from phase 2 or later and thus postdate 1872.

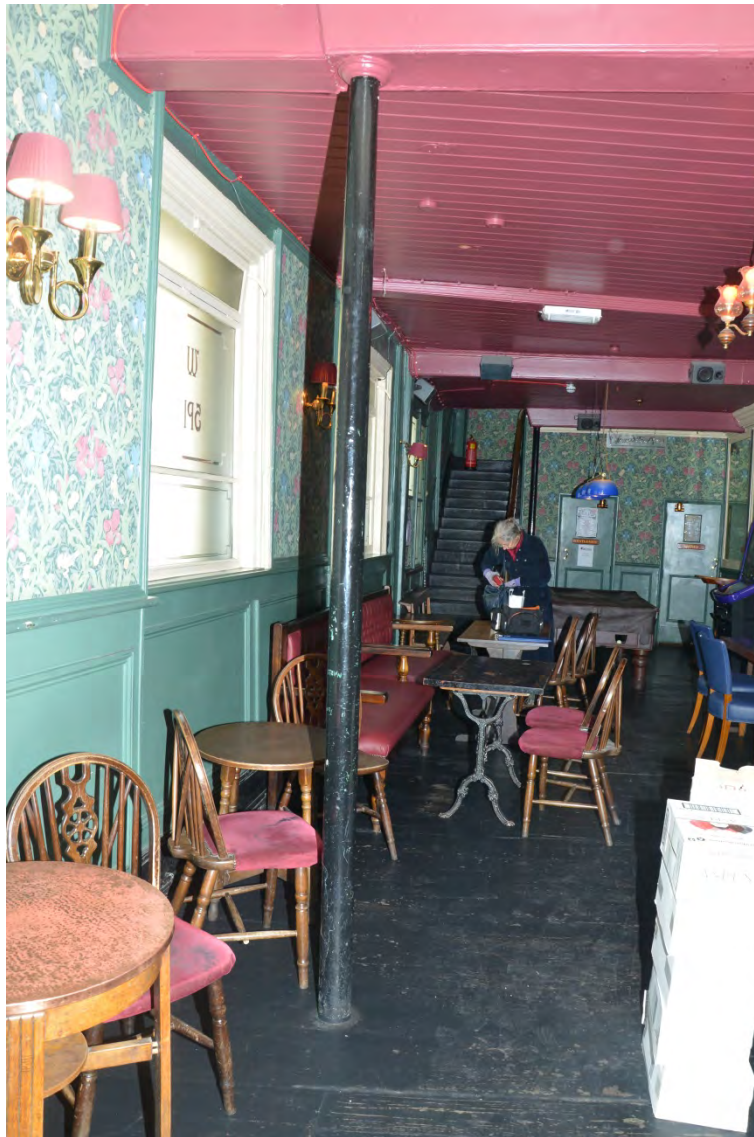
Plate 7: Detail of iron column

Two iron columns are present supporting the ceiling / first floor. These have plain mouldings at their heads. The head of the southernmost column appears to be located on top of the tongue and groove ceiling, suggesting the column was inserted after the ceiling was installed.

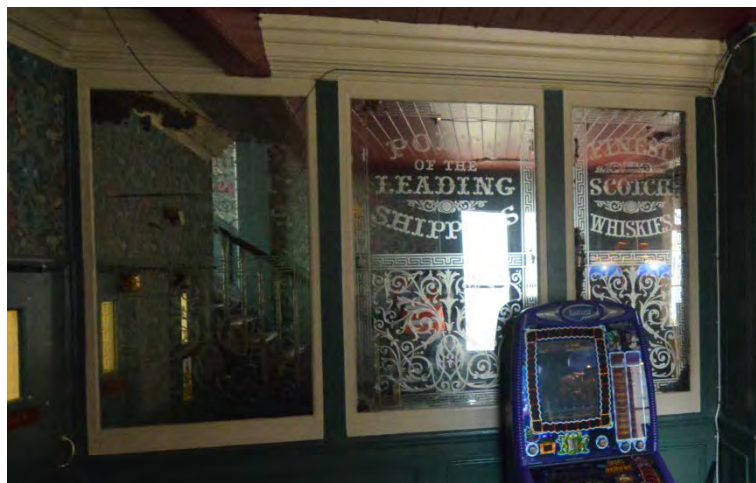
Plate 10: Etched mirrors to the northern end of the eastern wall, advertising 'Clarets of the Finest Vintages', 'Ports of the Leading Shippers' and 'Finest Scotch Whiskies'
No brand names are mentioned, therefore these mirrors cannot be dated, other than stylistically to the same period as those to the south.

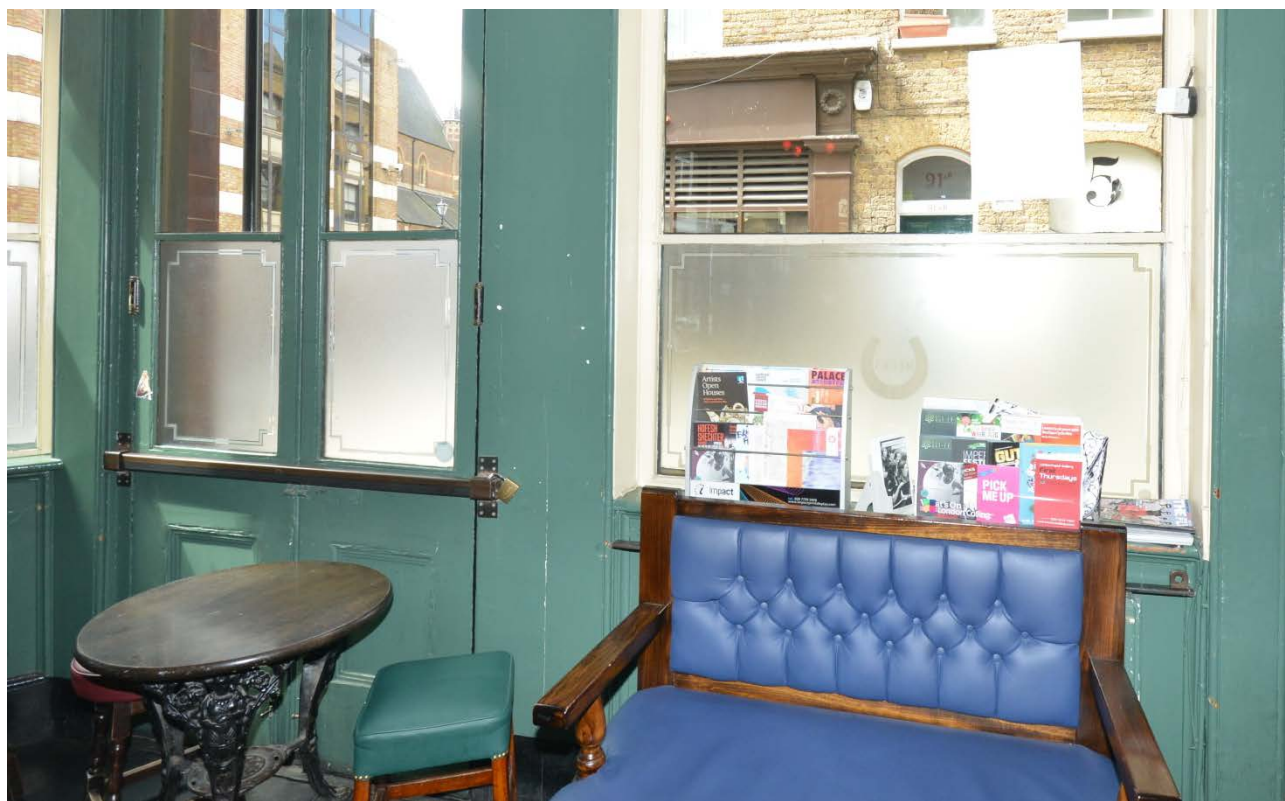
Plate 11: Windows, western elevation, etched with Meux's logo

Meux's Brewery Company Ltd was established in 1878 from the former company, Meux & Co. In 1956, Meux's merged with Friary, Holroyd and Healy to form Friary Meux.

The frosted windows with the Meux's logo must therefore date from the period between 1878 and 1956. As The Griffin was built in 1889, these may be original windows, although are equally likely to be later additions.

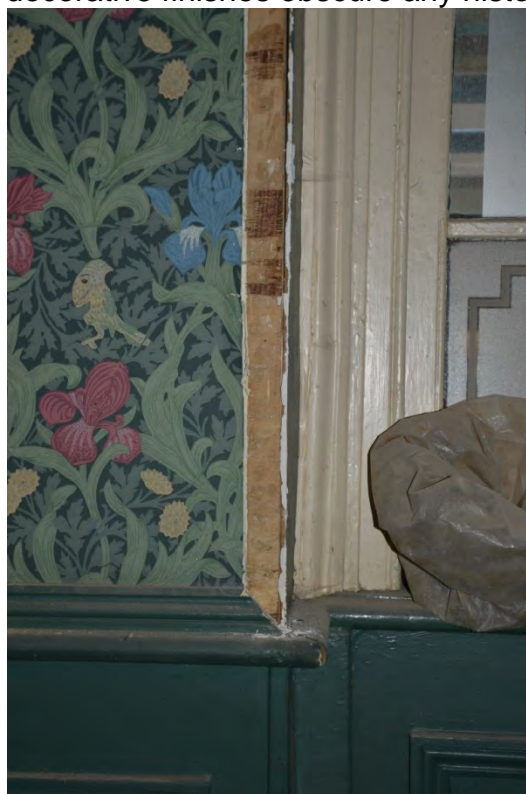
That to the west is, however, known to be modern in construction in one area at least, where recent works have shown it to be formed of modern plywood, boxing in services from the upper floors. It is unknown, therefore, how much, if any, of the panelling to the west is historic as modern decorative finishes obscure any historic detail.

Plate 19: Modern plywood revealed during recent works

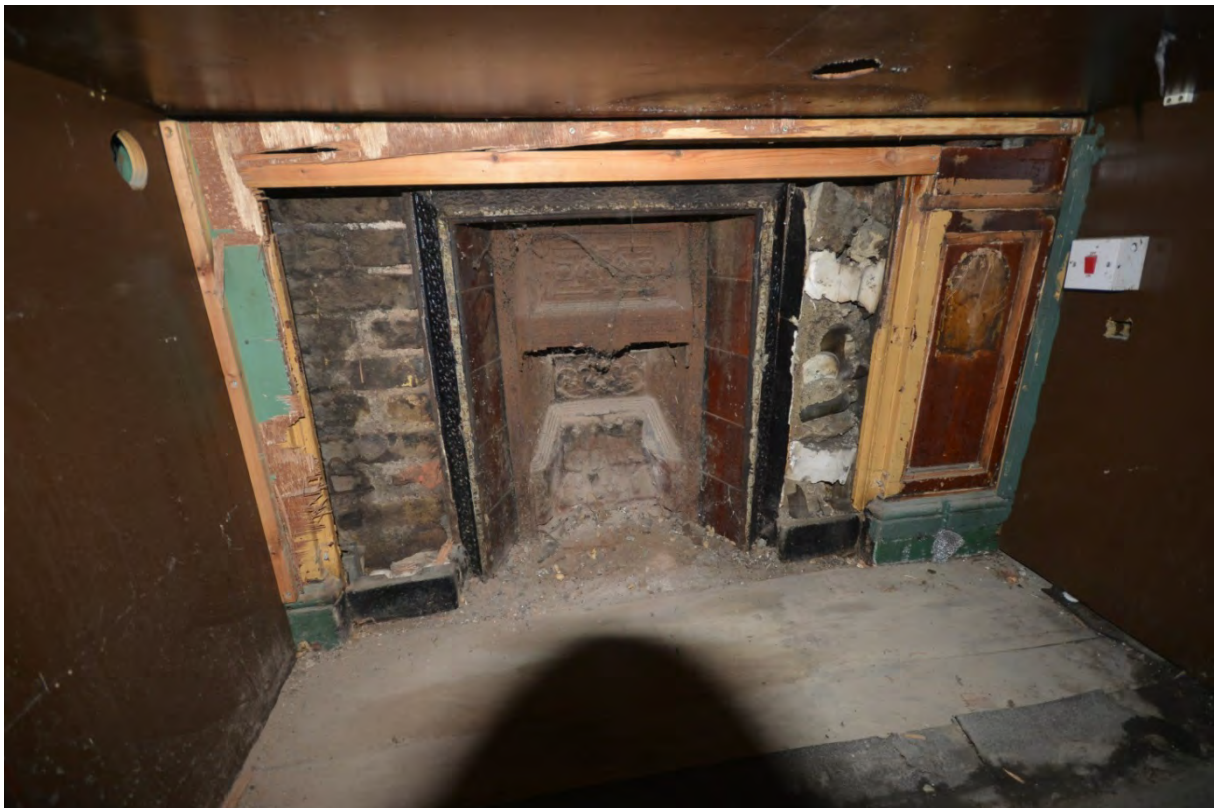
Plate 28: Fireplace revealed during strip of back bar area

The fireplace depicted above was revealed during stripping of the back bar area towards the southern end of the servery. This form of fireplace is common to the late 19th – early 20th centuries.

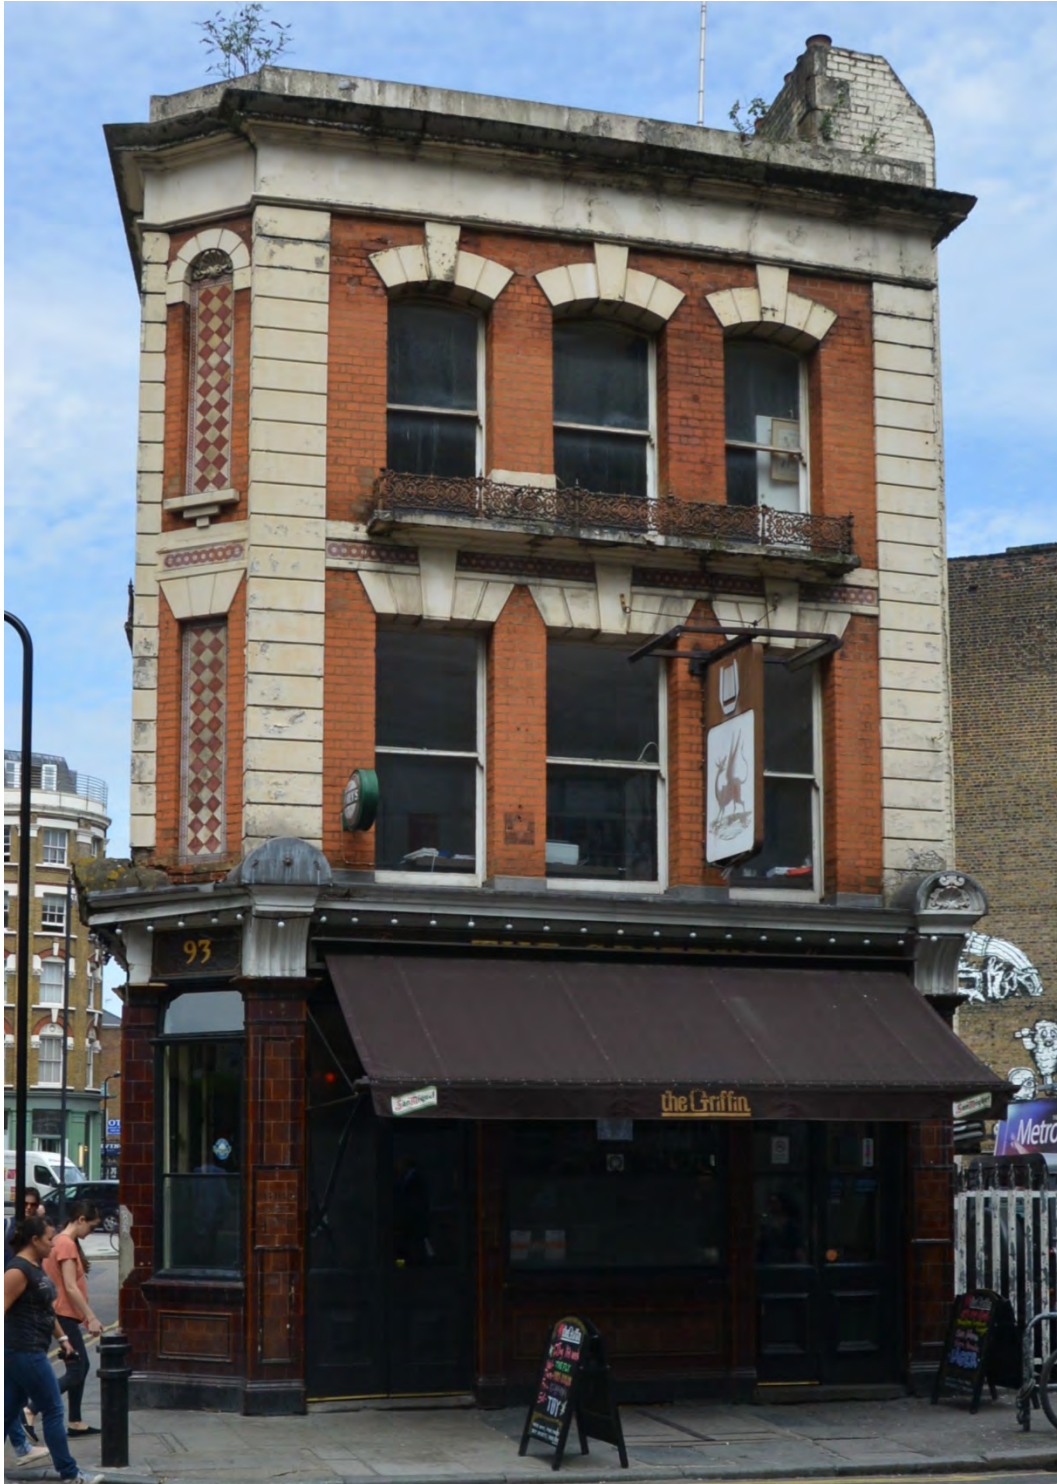
Plate 29: South elevation

The building is a three-storey Victorian corner public house with a glazed frontage to the ground floor on the south and west sides.

The southern elevation, forming the frontage of the building, features a parapet with projecting canopy. Below, the wall is of pale orange regular bricks.

The south elevation features three windows on each of the upper floors, arranged symmetrically. The windows are horned sashes with single panes, indicating a late Victorian date. The second floor windows feature cambered segmental stone lintels whilst those on the first are straight.

The second floor windows feature a small projecting balcony with ornate cast iron balustrade. The dimensions of this are such that it appears too small to support any great weight and is considered to be a decorative feature. The listing description suggests these are window boxes. There is no reason to doubt this suggestion.

Dressed stone quoins are present at each end of the southern elevation.

Separating first and second floor windows, a course of terracotta tiles with a pattern in red set on a white background.

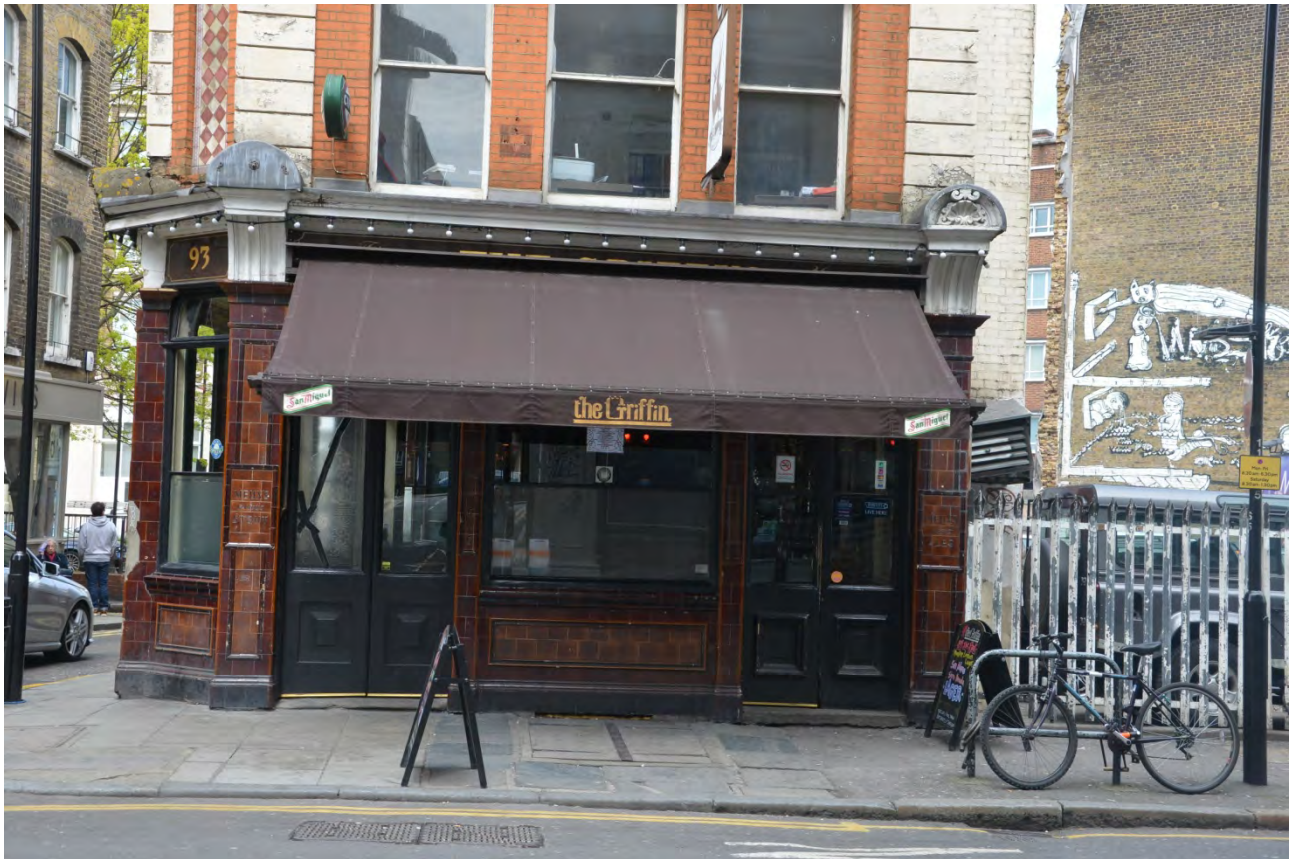
Plate 31: Detail of ground floor south

The ground floor features a pair of double doors flanking a central window. An awning is present over the brown and green glazed frontage. Either side, moulded brackets are present.

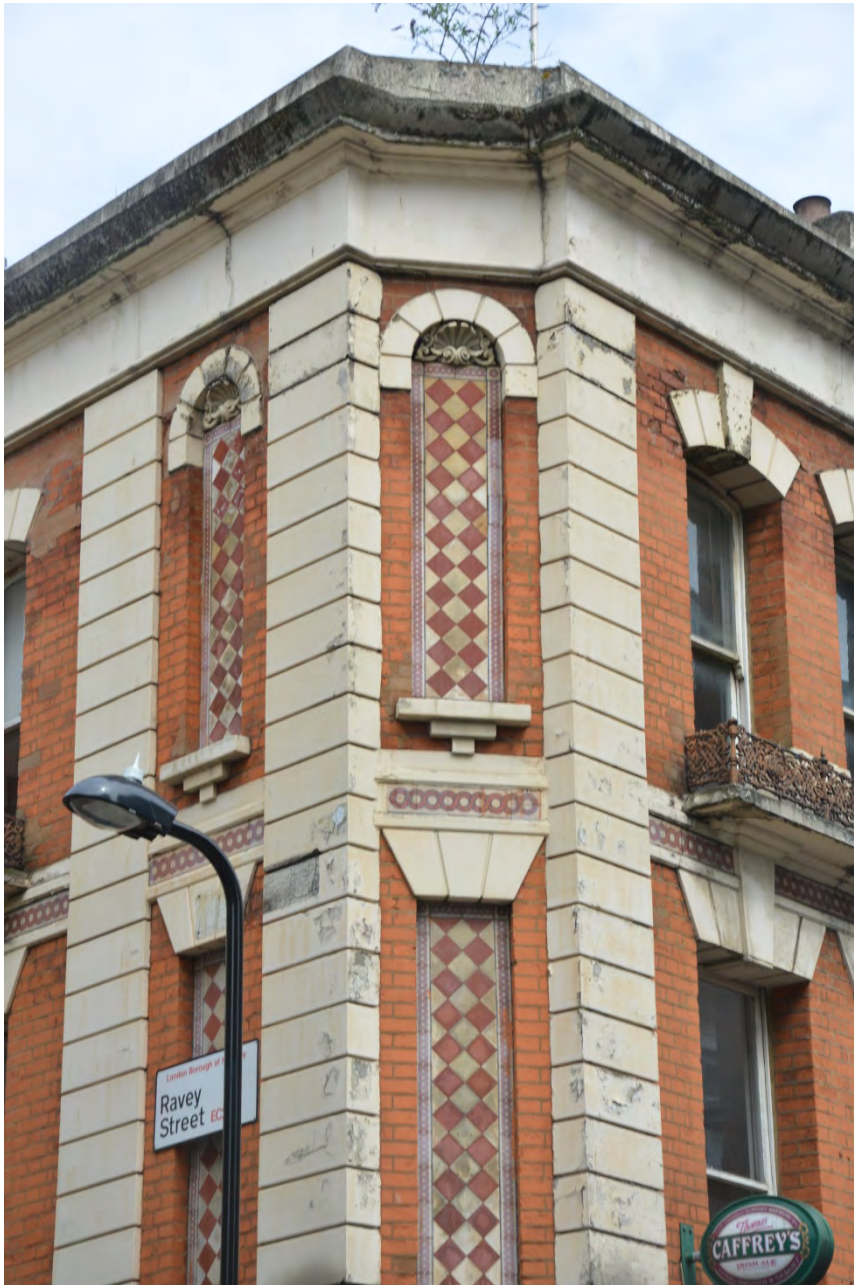
Plate 32: Detail of decoration on southwest corner

The southwest corner is angled, continuing the pattern of lintels surrounding panels of tiles in a harlequin pattern.

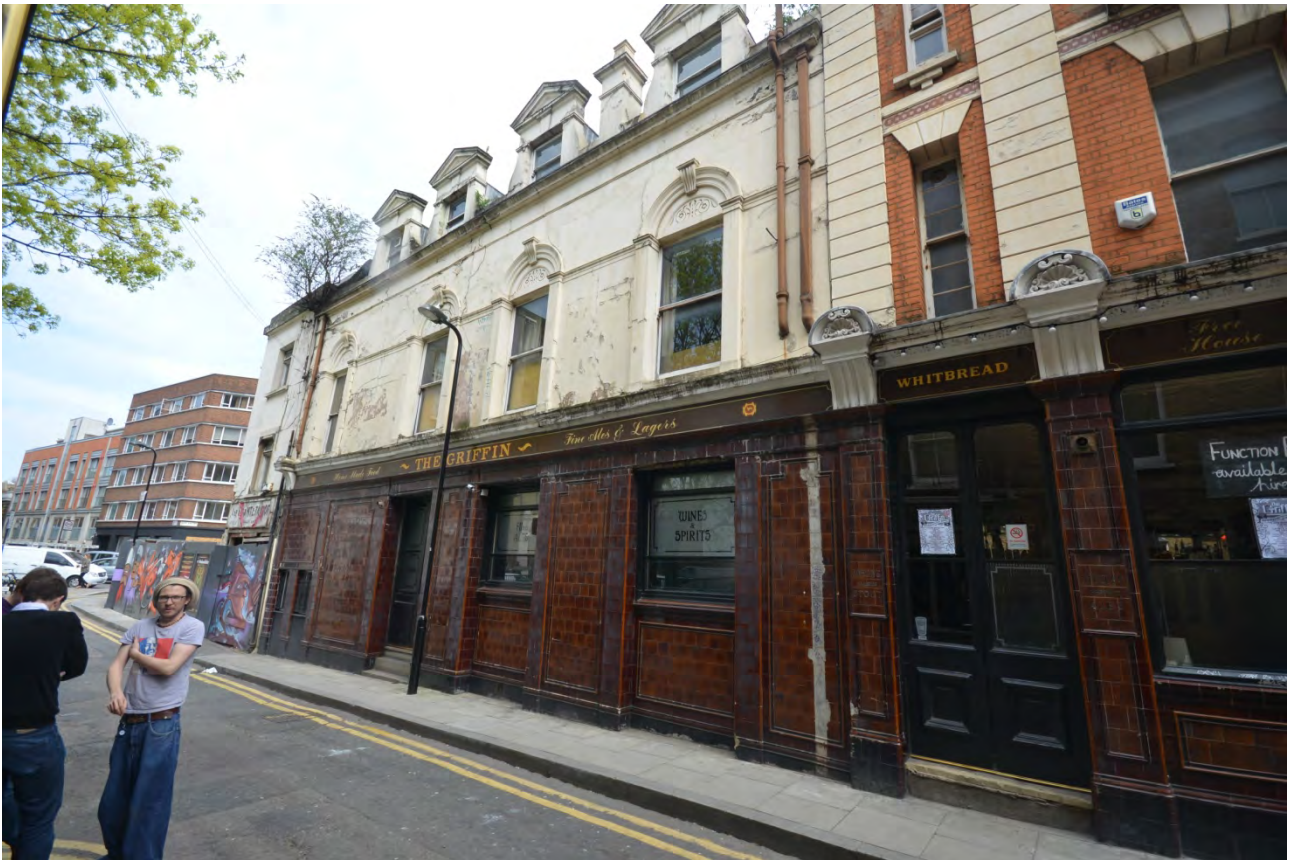
Plate 34: Northern part, west elevation

The western elevation of the building is divided into two parts. To the north, the roofline is lower than that to the south, and the wall is rendered. This contrasts the higher southern part of the building which continues the pattern of the southern elevation. The glazed ground floor continues across the west wall.

Four pedimented dormers are present with classical stucco mouldings. At first floor level, four windows are present with stucco arched mouldings. All the upper floor windows are again horned sashes.

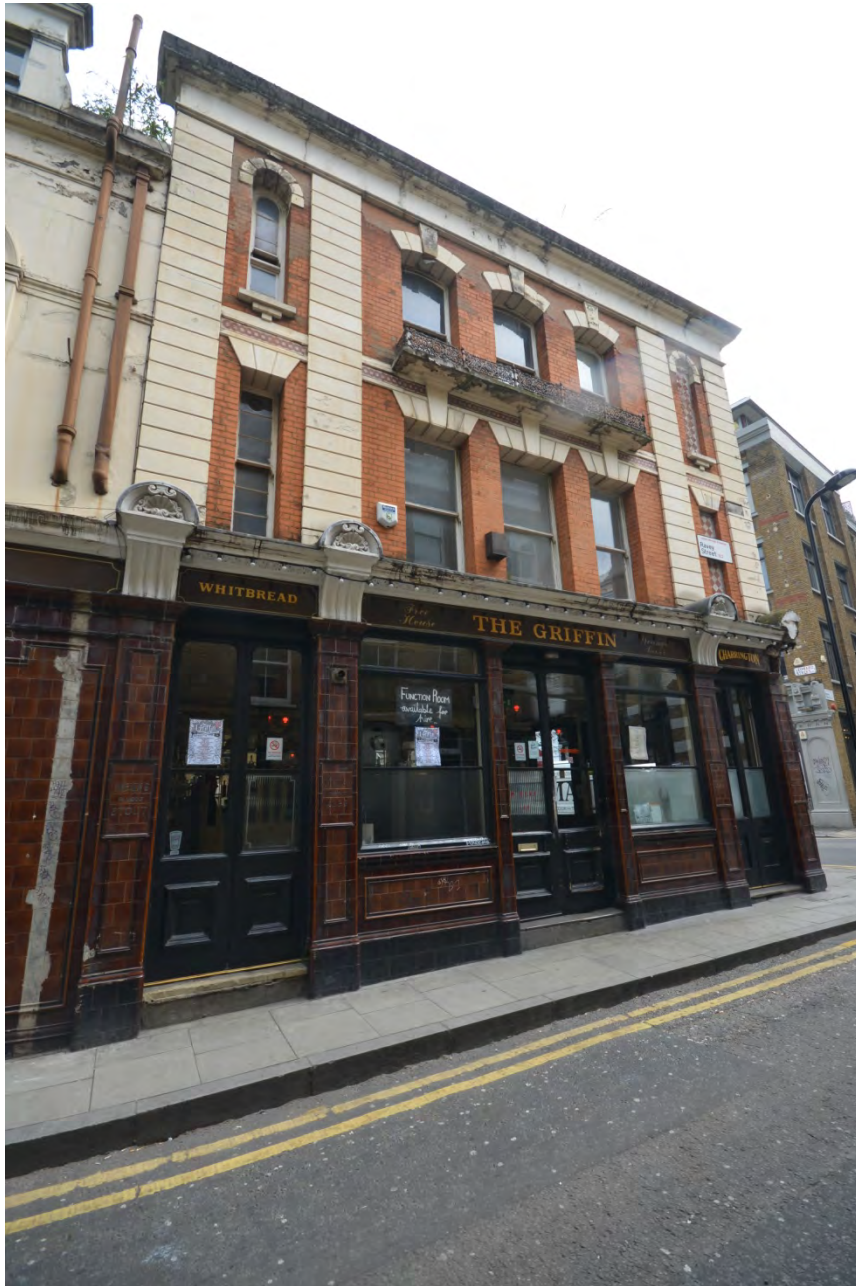
Plate 35: Southern part of west elevation

Four sets of doors are present along the western wall, interspersed with windows, some etched with advertising for the wares of the public house. Further advertising is present in the tiles either side of the doors and in a large panel to the north.

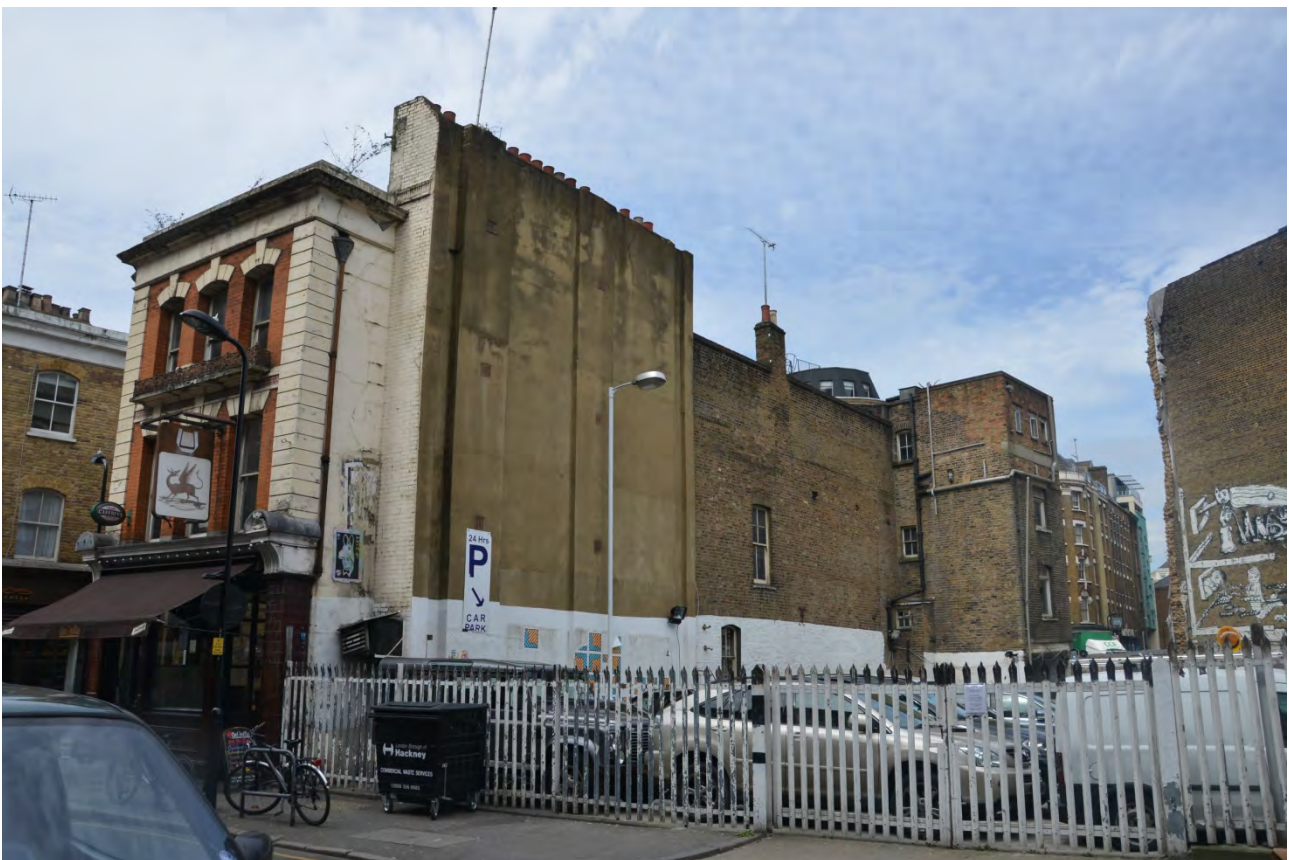
Plate 41: General view, east elevation

The eastern elevation is plain. To the south, a significant portion of the wall is formed by a rendered chimneystack with a large number of chimneypots at its head. To the north, the wall is of plain hand-made brick with a parapet at its head. A single chimneystack is present, and a pair of windows can be seen, one at first floor level, the other on the ground

floor. These have cambered brick lintels. To the south of the ground floor window, a further arched lintel indicates the position of a former large opening.

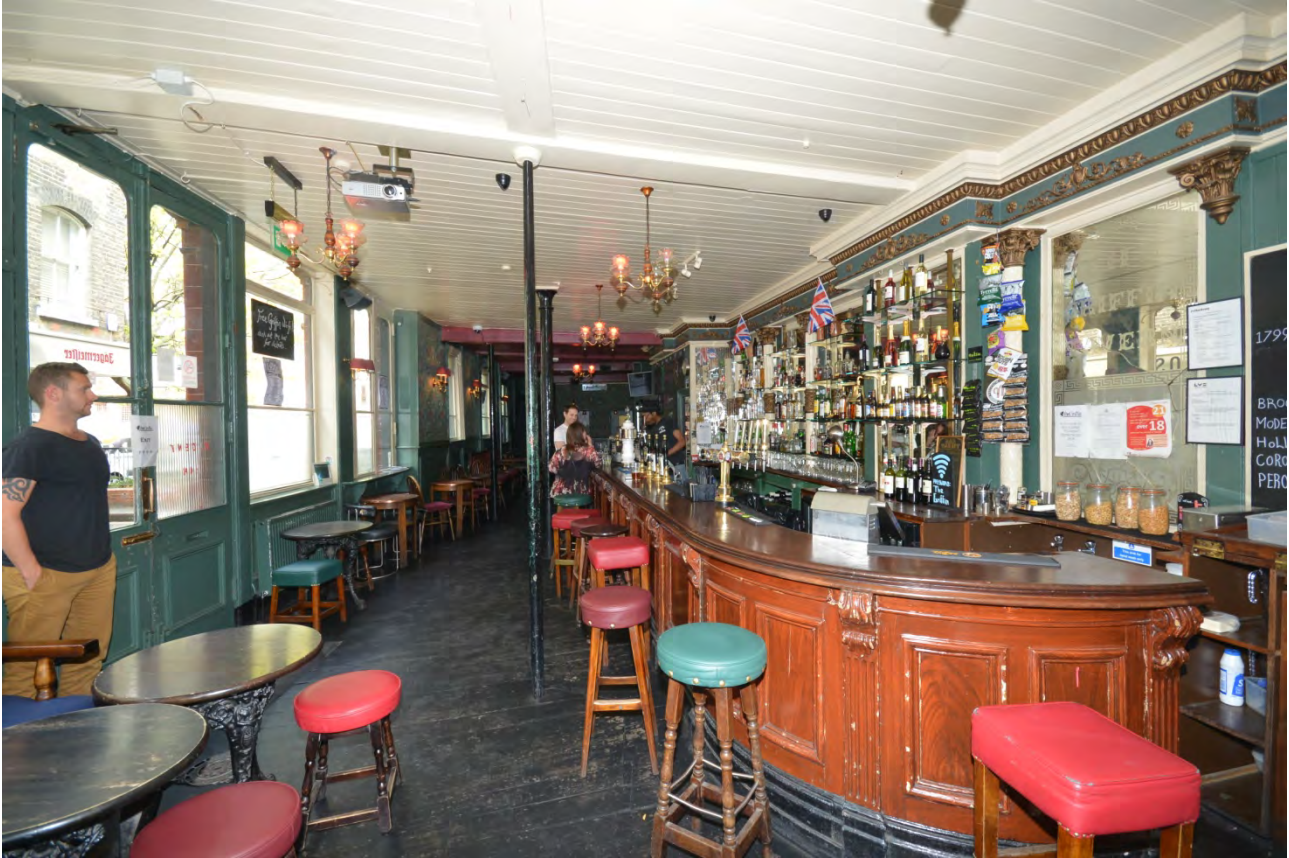
Plate 55: North aspect, bar area, prior to closure of pub

The ceiling is clad in planed planks. East-west beams are present, supported on iron posts. The walls are panelled below dado level.

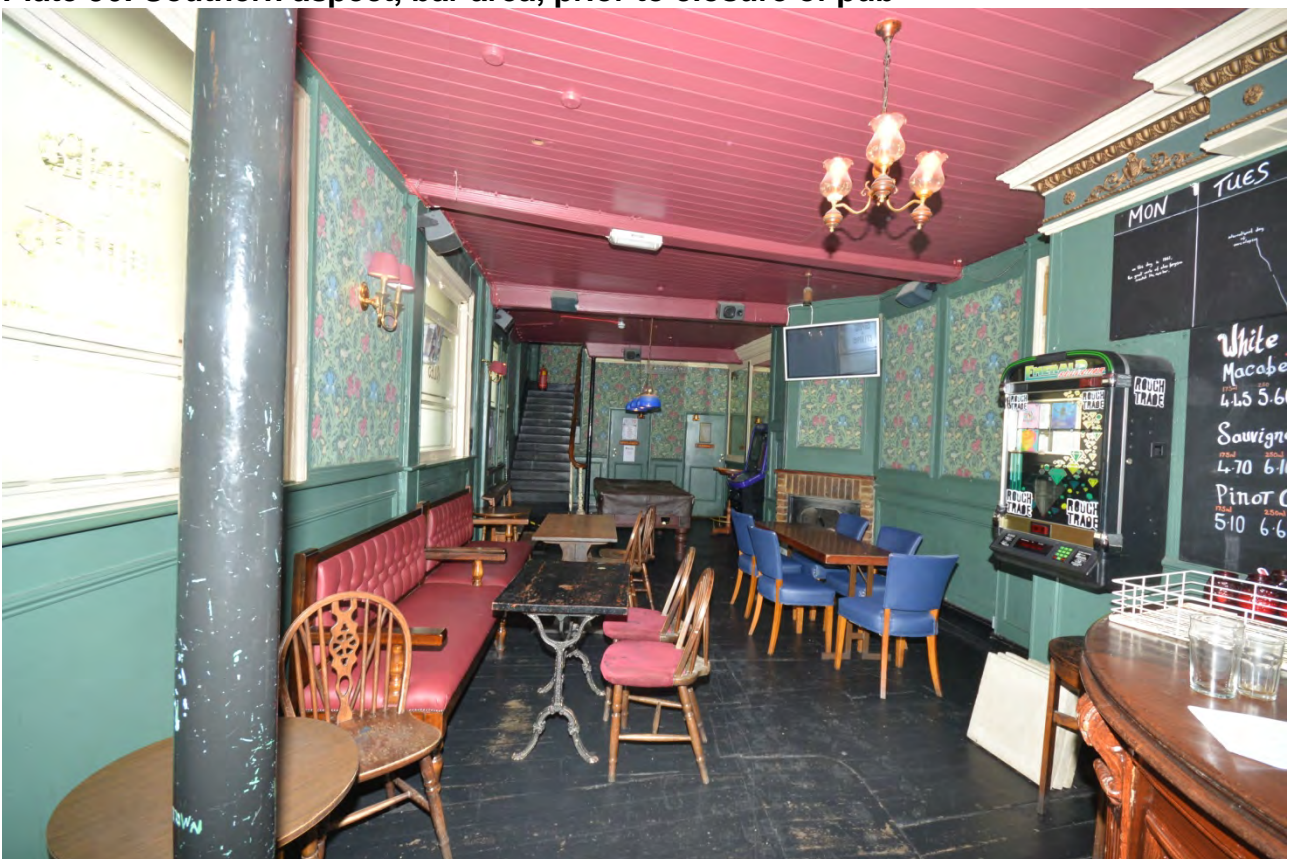
Plate 57: North aspect, rear of bar area, prior to closure of pub

The walls of the rear part of the bar are panelled over their full height. Modern paint finishes obscure any constructional detail.

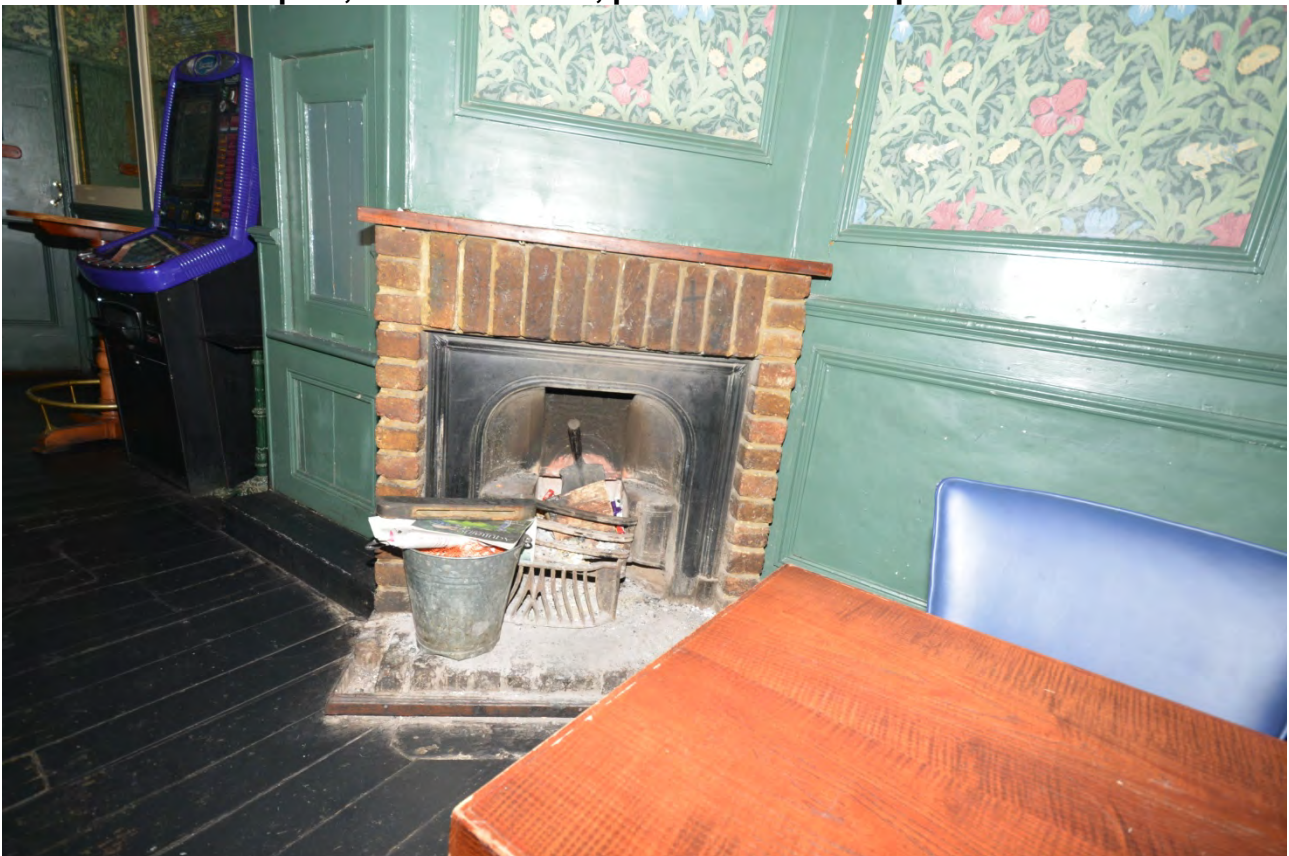
Plate 59: Detail of fireplace, bar area, prior to closure of pub

A 19th century cast iron insert fireplace is present in the eastern wall of the bar. To its north, the hatch to a dumb waiter can be seen.

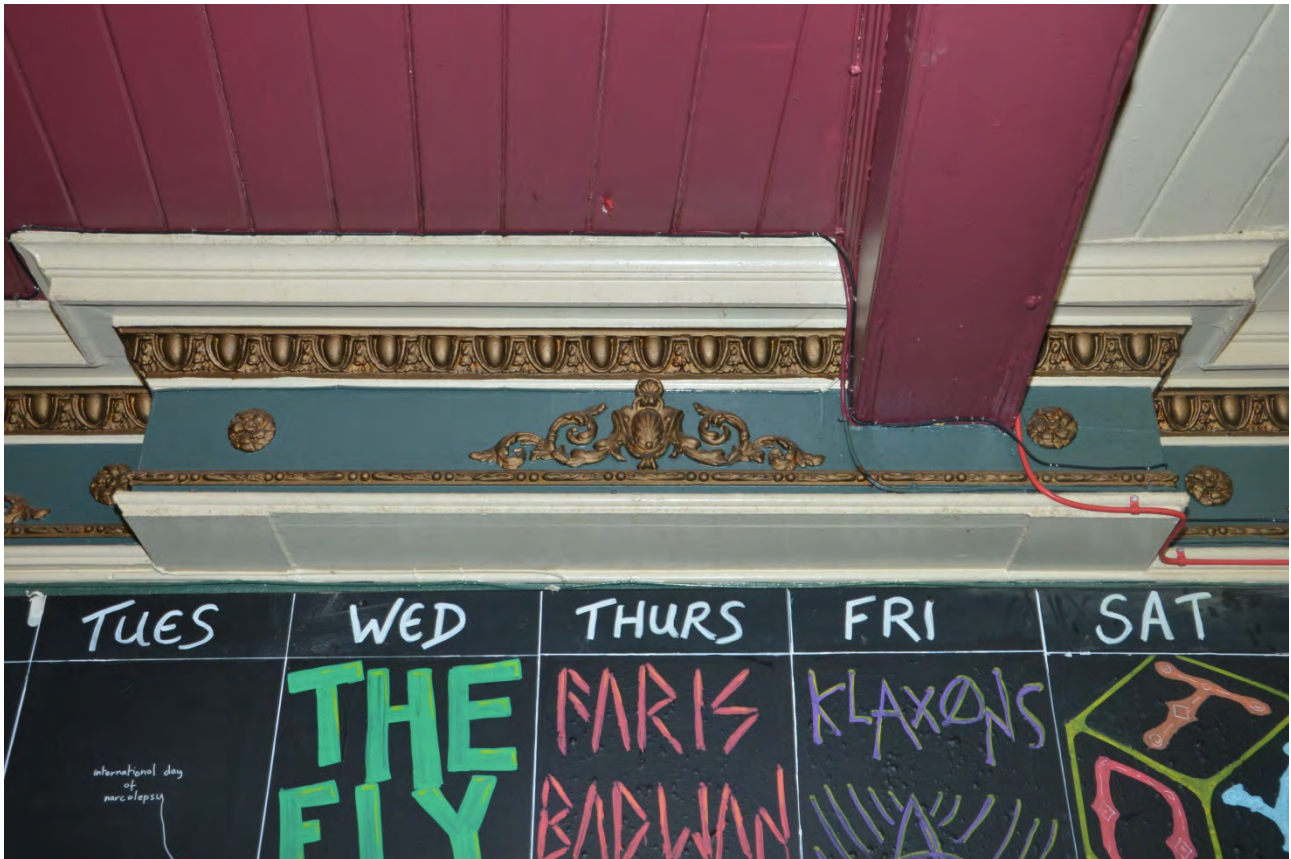
Plate 60: Detail of mouldings and panelled ceiling

Ornate mouldings are present around the head of the eastern wall and the bar servery area in 19th century style.

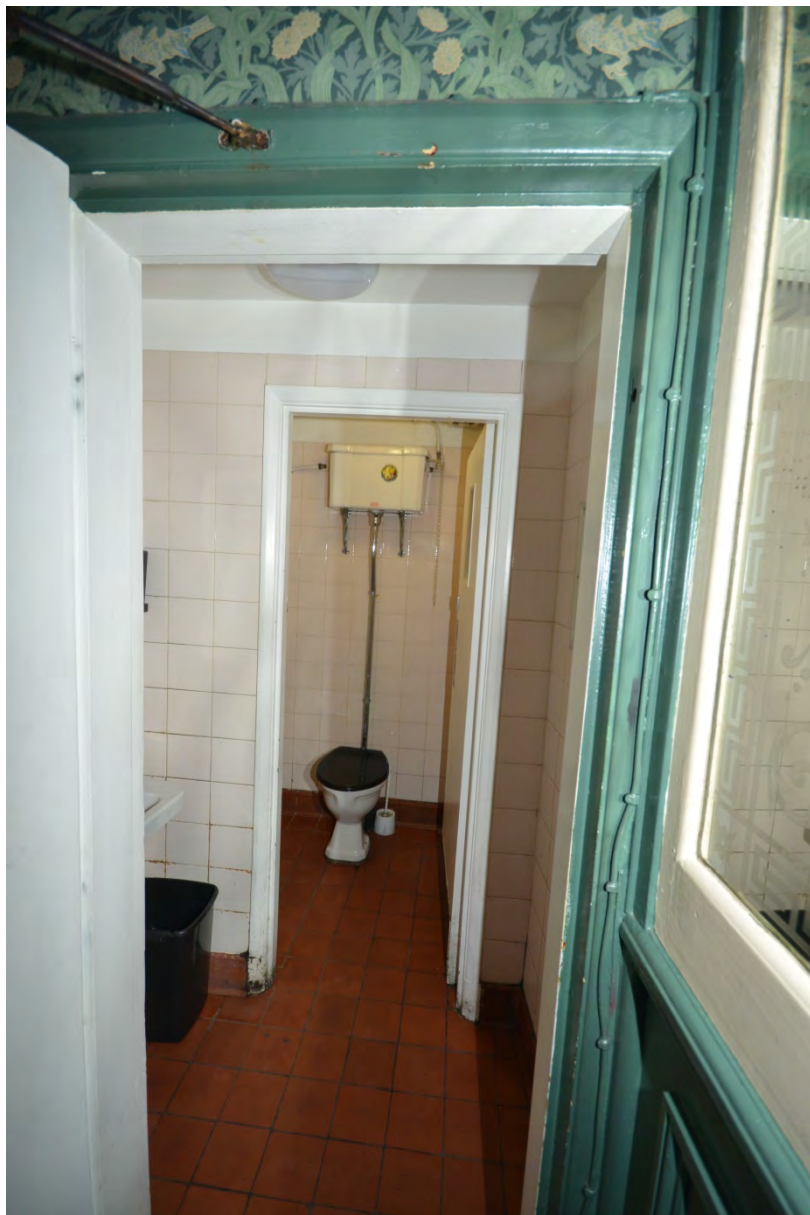
Plate 63: Ladies' lavatory, prior to closure of pub
The lavatories are tiled obscuring any historic detail.

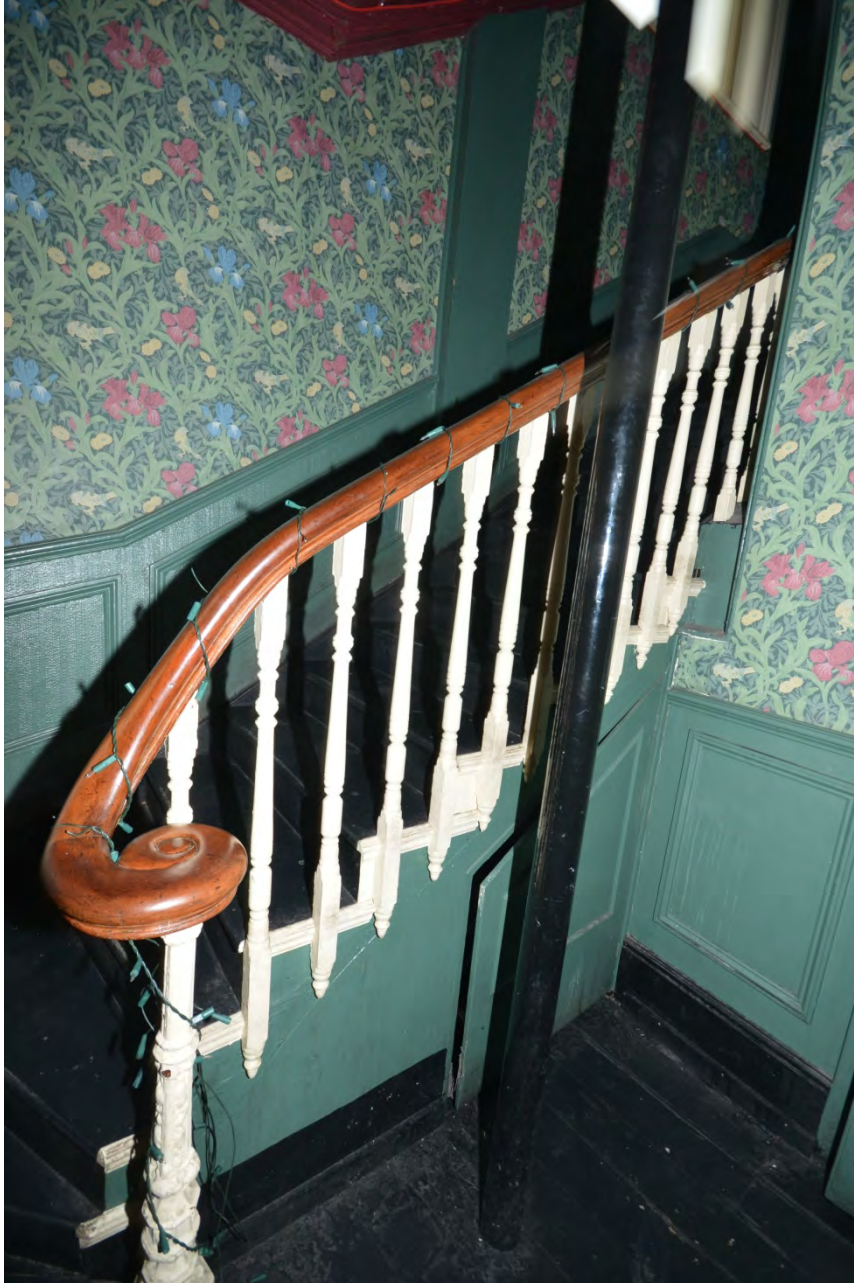
Current Function	Staircase
Original Function	Staircase
Phase	2
Plan Form	Unaltered
Windows	None
Historic Features	Balustrade, panelling, planked ceiling
Comments/Description	Exposed lath and plaster on underside of dogleg staircase, cornice

Plate 76: Detail of balustrade

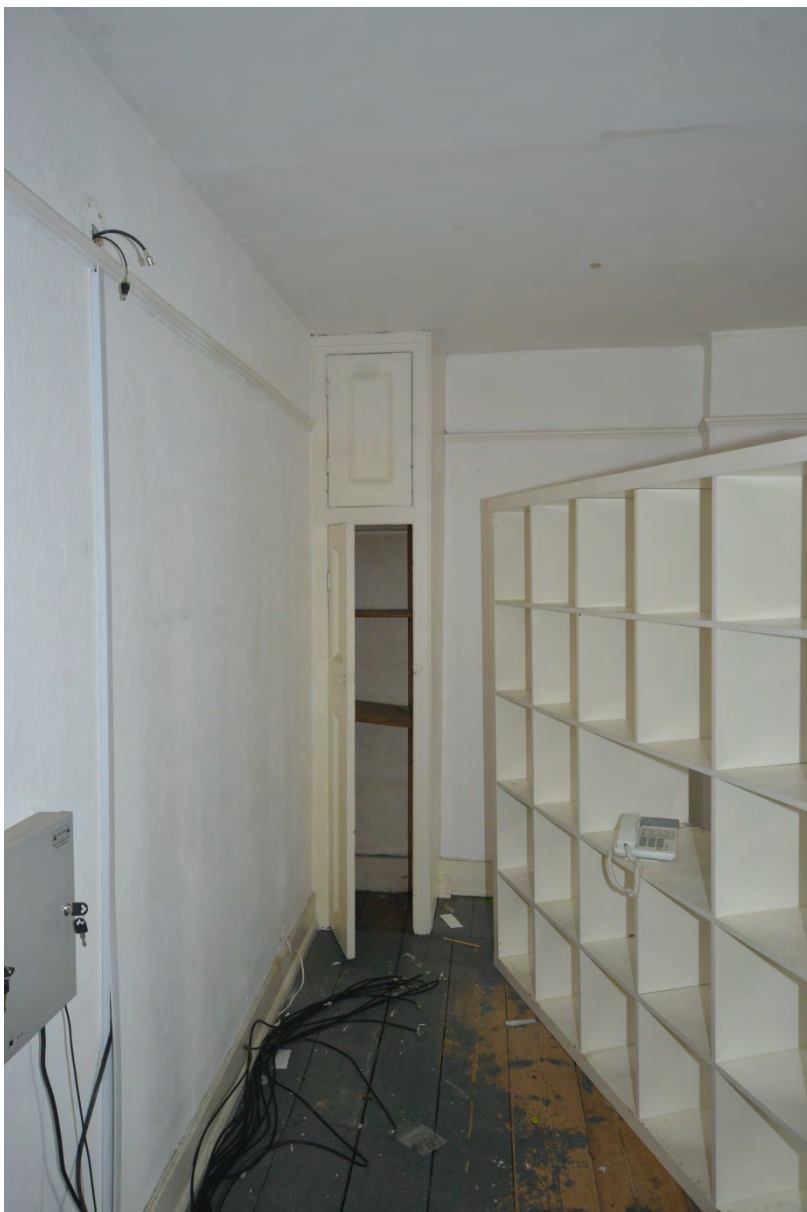
Cupboard in northeast corner (not original)

Plate 104: Detail of cupboard, northeast corner
