BUILDING RECORDING

The Griffin Public House

93 Leonard Street
Shoreditch
London

Document Reference Number 2013/1141
Version 2

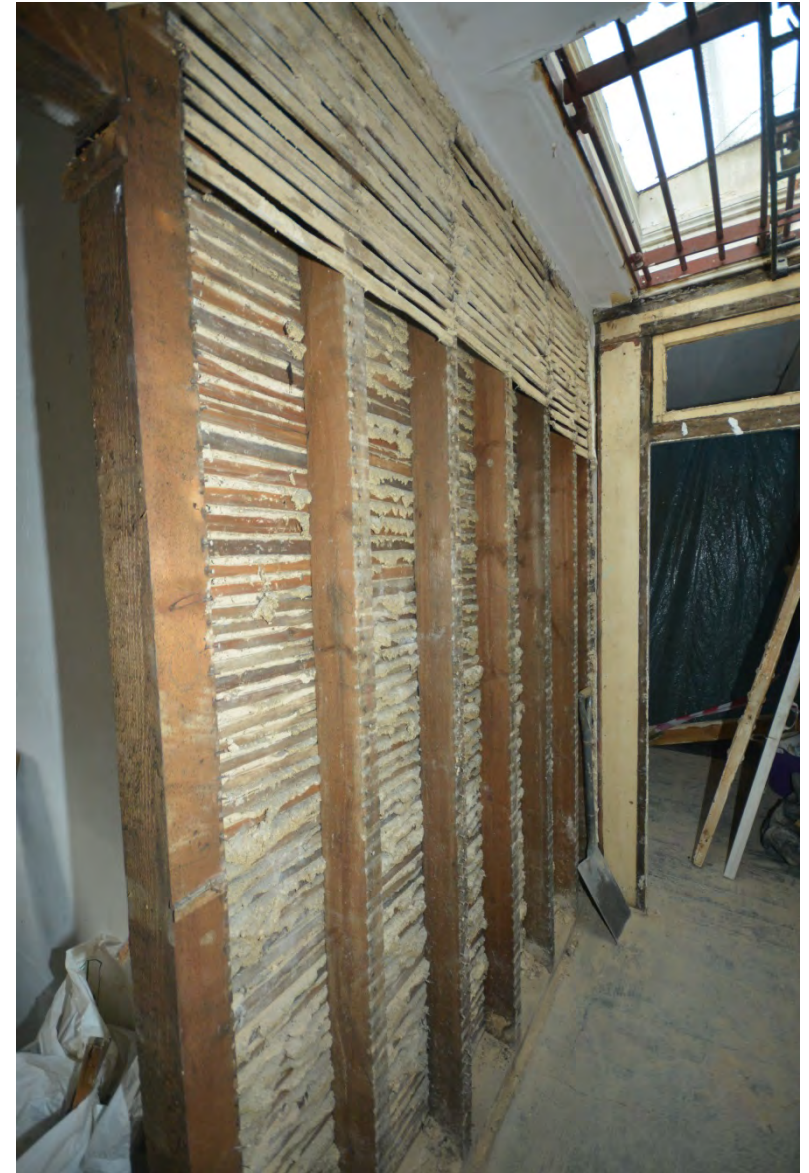
Plate 111: Detail of western wall during demolition

The above photograph shows the lath and plaster construction of the wall.

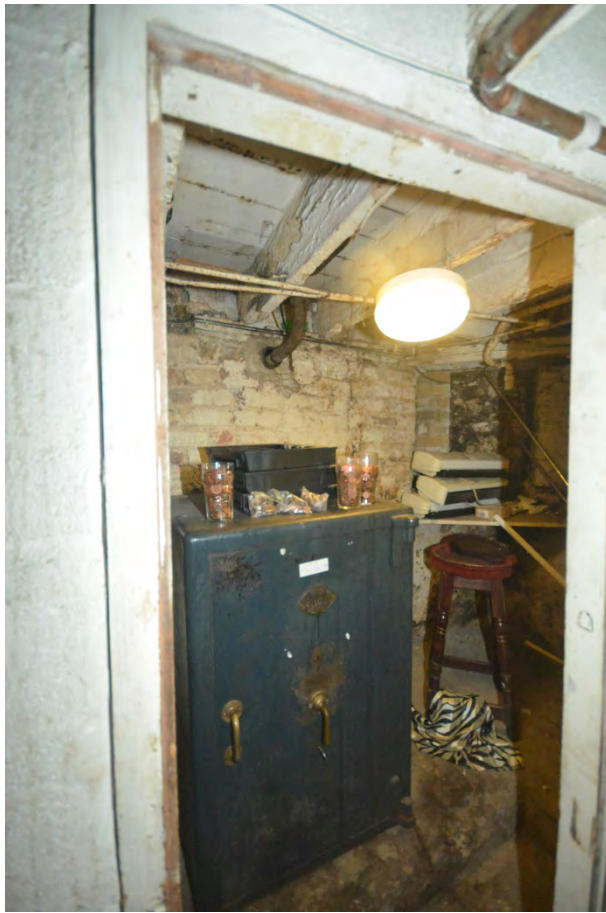
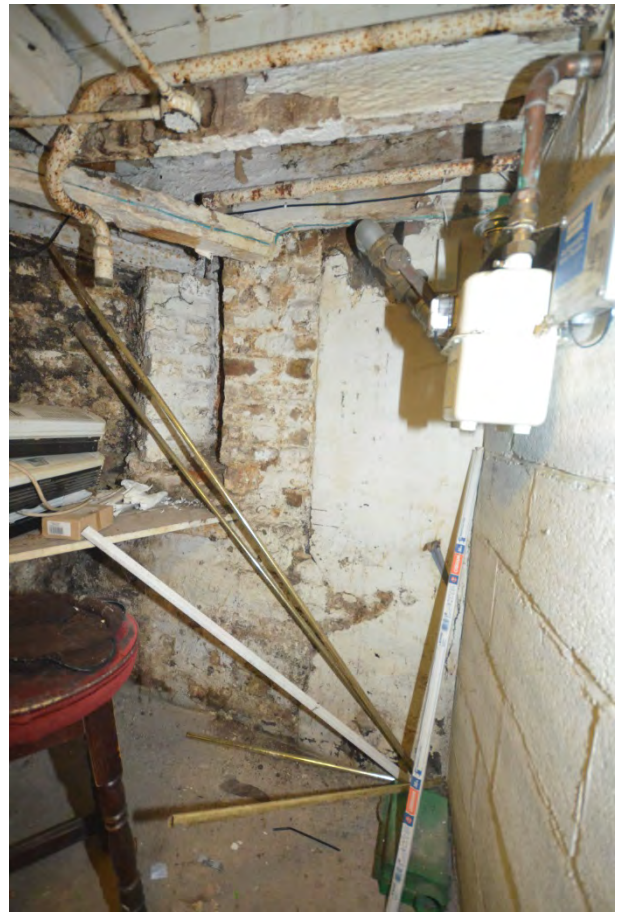
Plate 159: View into southwest partition room

The southwest partition room is constructed of modern concrete blocks.

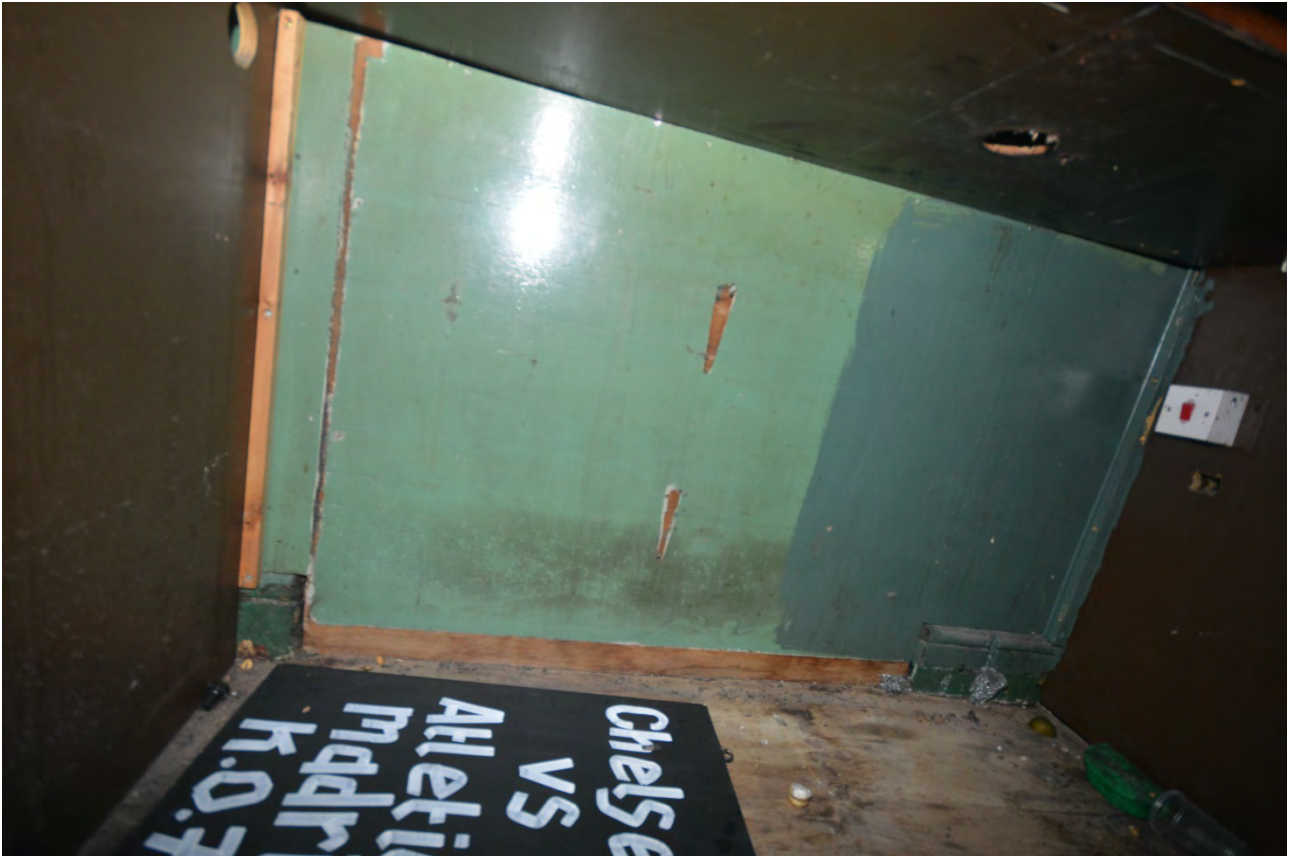
Plate 168: Former refrigerator recess showing board blocking fireplace

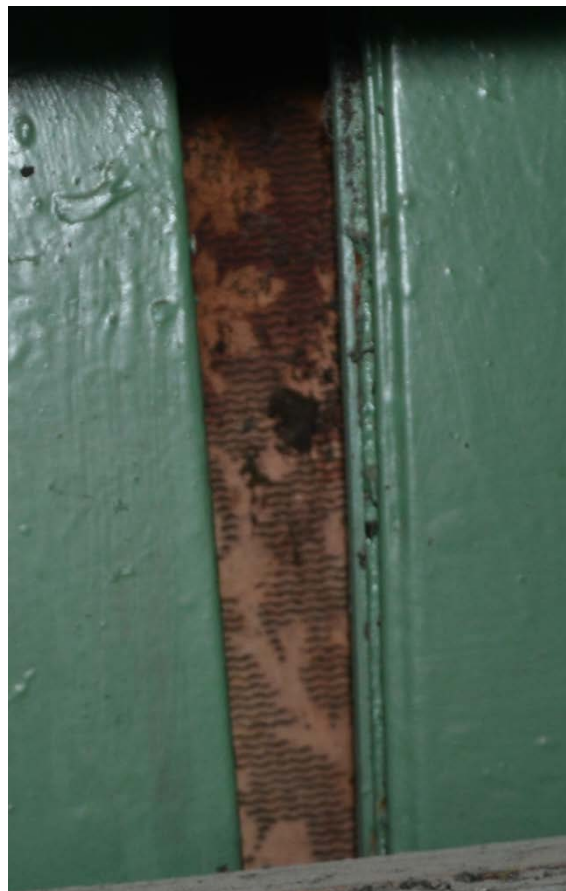
To the north of the fireplace, a gap in tongue and groove panelling at the rear of the under-counter shelving has revealed historic wallpaper with a floral motif of an uncertain date. It is clear, in this area at least, the tongue and groove panelling cannot be original.

Plate 170: Detail of wallpaper pattern

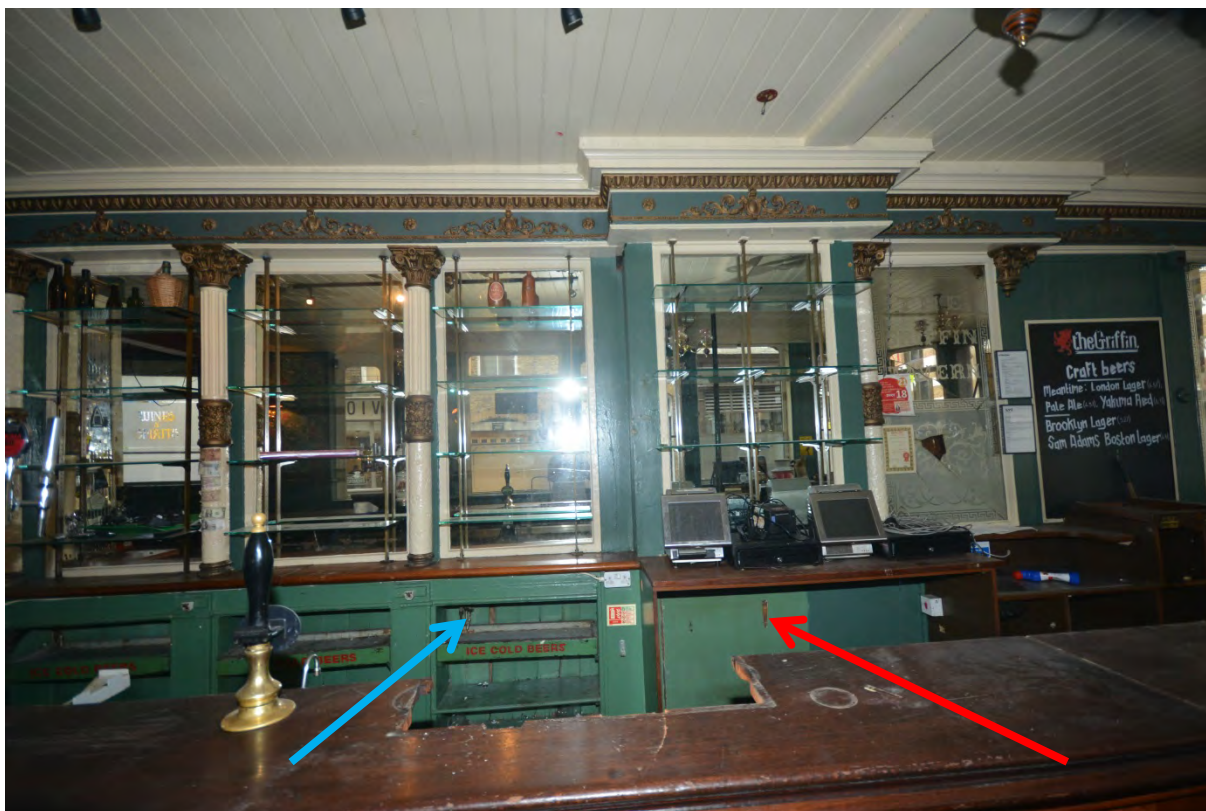
Plate 171: Location of fireplace (arrowed red) and wallpaper (arrowed blue)
The above photograph clearly shows the chimneybreast leading up from the fireplace.

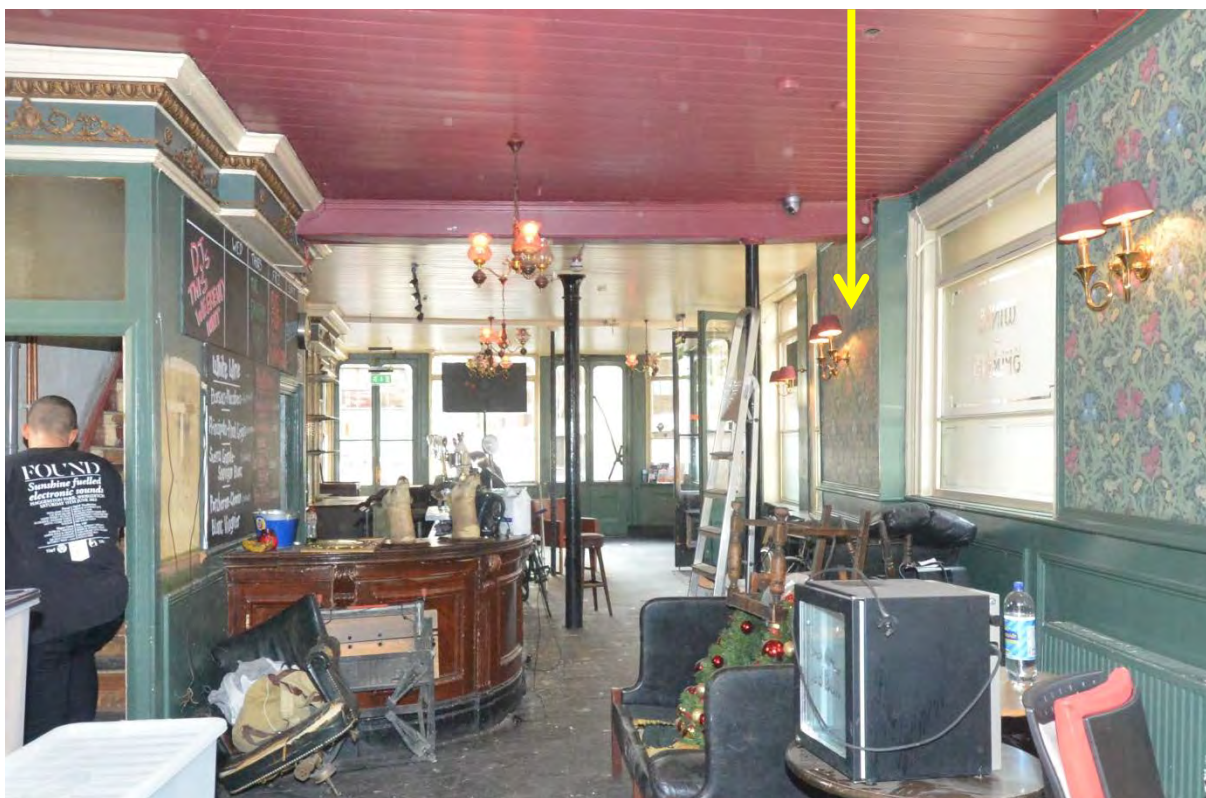
To the west of the building opposite the northern end of the bar counter, a section of wall has been revealed to be of modern plywood construction, boxing in a soil pipe which runs from the upper floors.

Plate 172: Location of plywood boxing (arrowed)

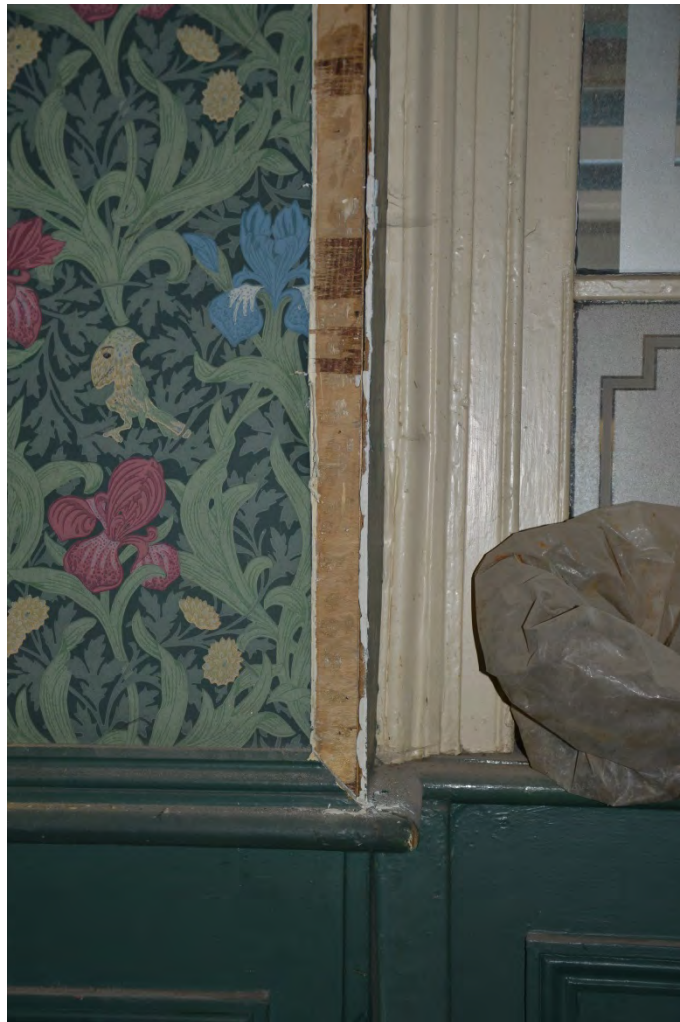
Plate 173: Plywood boxing in of soil pipe

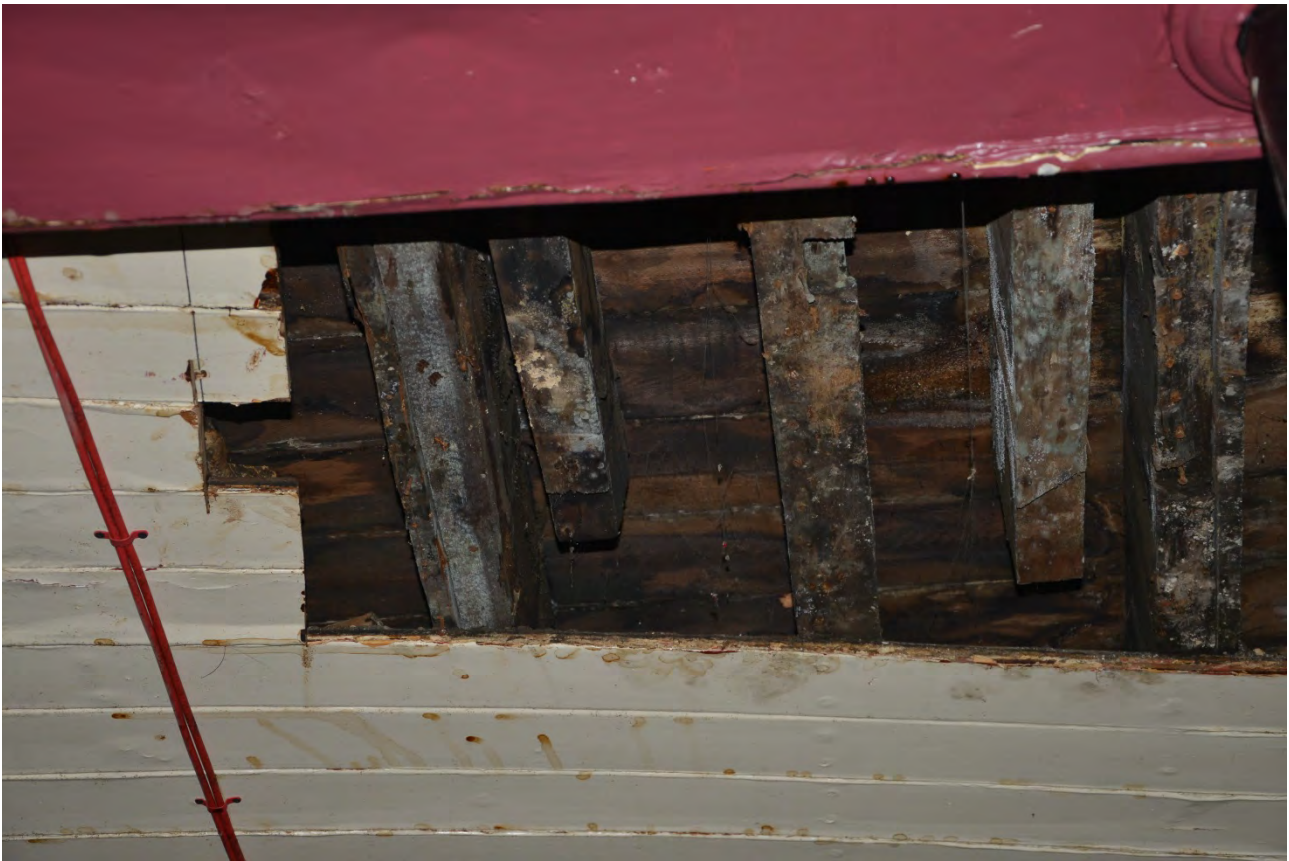
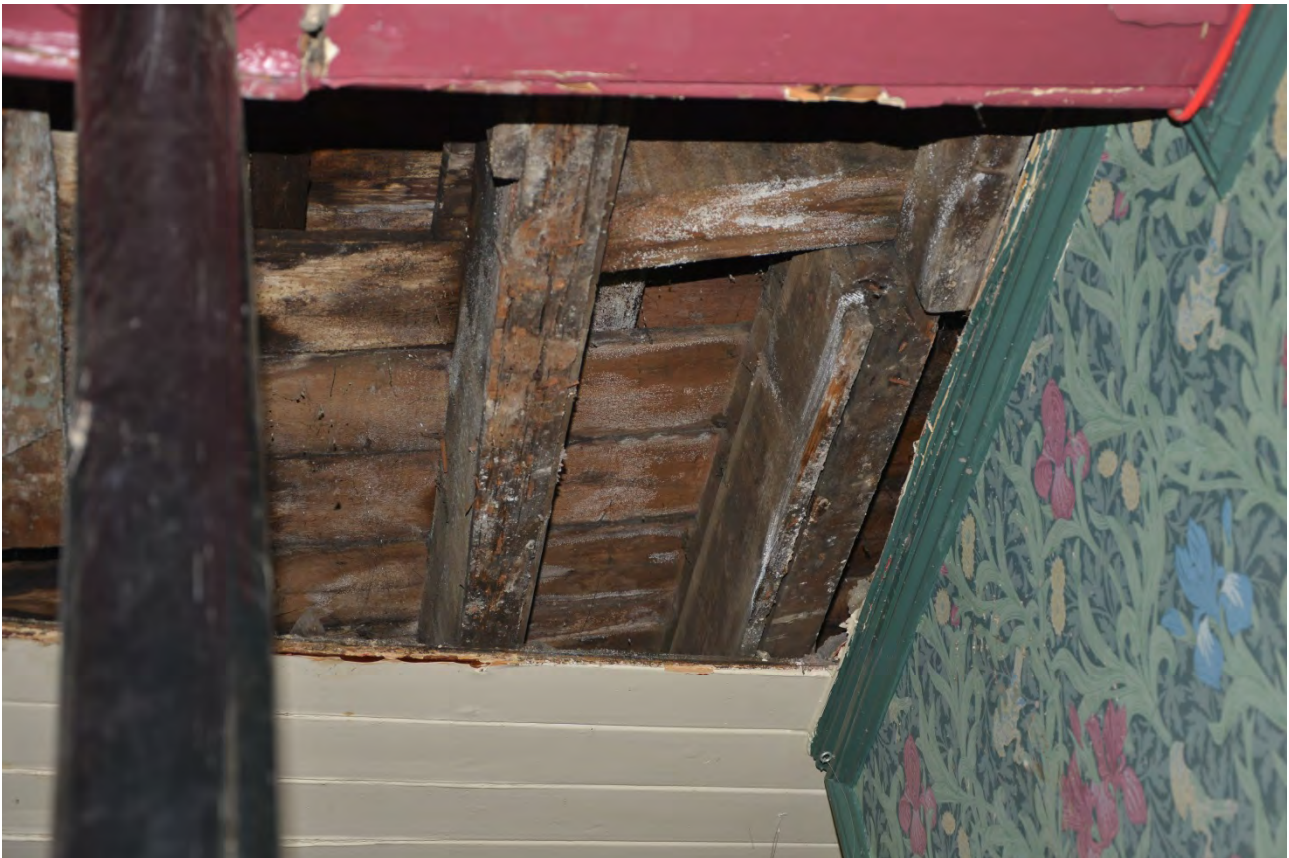
Exploratory works to the ceiling of the building have exposed timbers supporting the first floor. These are all machine-sawn and are in varying states of integrity.

Plate 174: Exposed ceiling / first floor timbers, area A

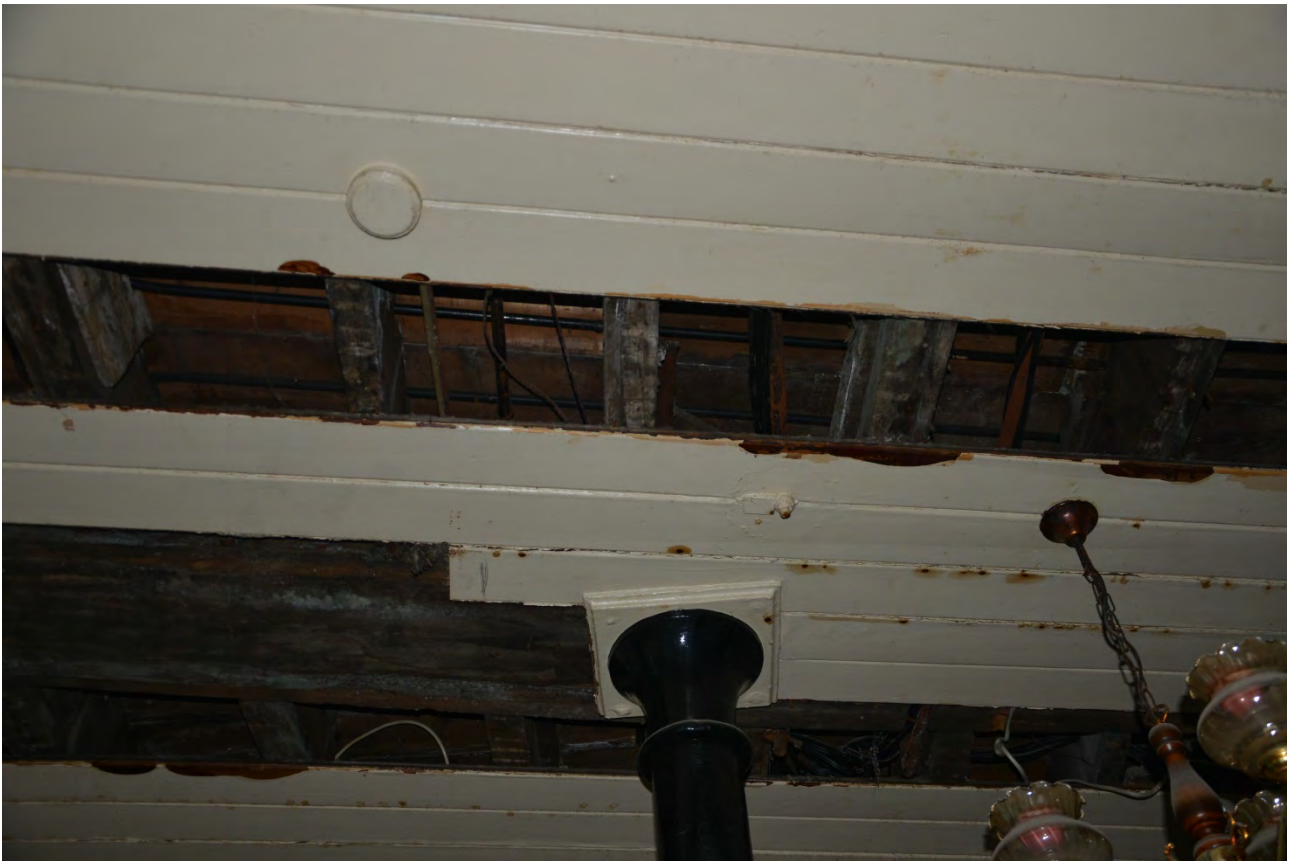
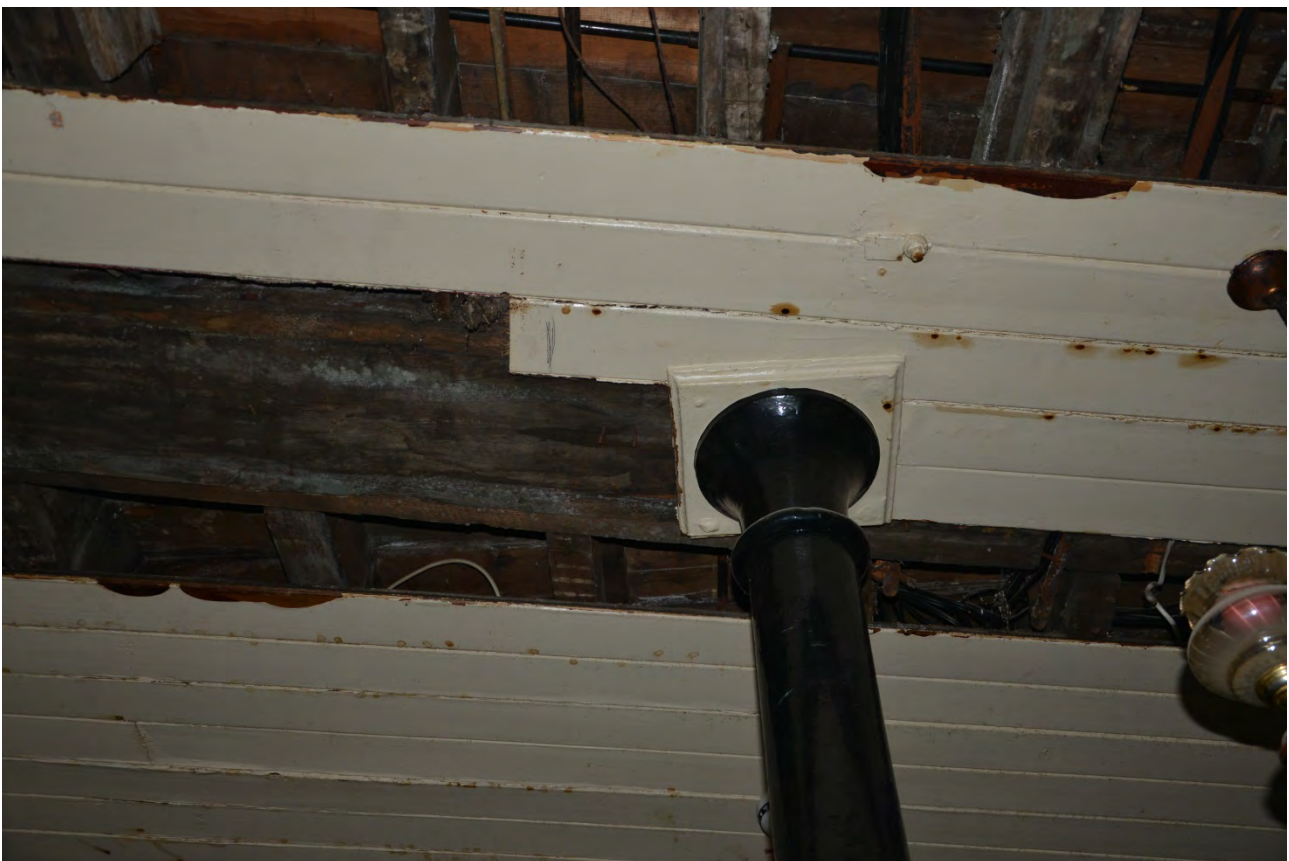
Plate 176: Exposed ceiling / first floor timbers, area B
